# Qalaat Ja'bar Report 2022

## Historical and Archaeological Study, Damage Assessment, Current Situation, Stabilization, and Proposed Restoration

Presented by: Khaled Hiatlih - Yasser Shauhan - Ristom Abdo

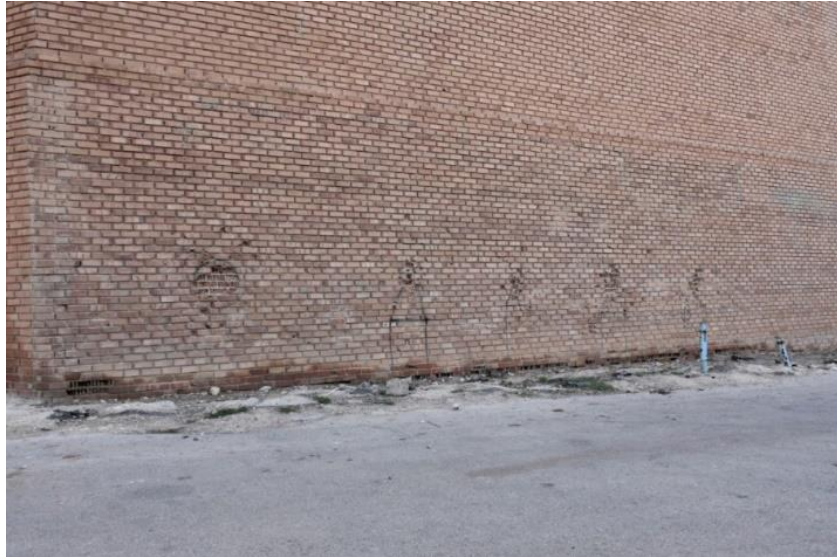
A picture showing the effects of the (Ashbal al-Khilafa) training on firing on the newly restored retaining wall in the western part of the walls of The Citadel of Ja'bar

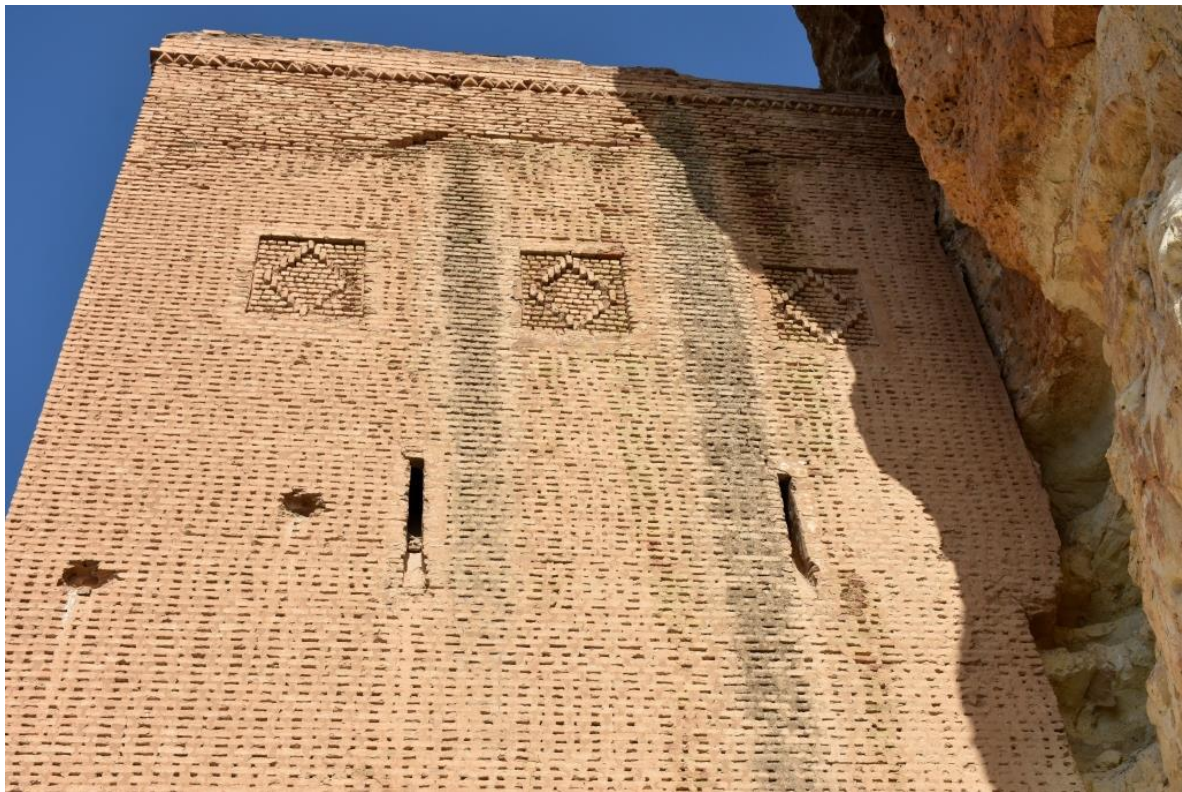
Aliaa Tower (T30) hit by light and medium weapons, Photograph: Zardasht Ezzo, February 2021

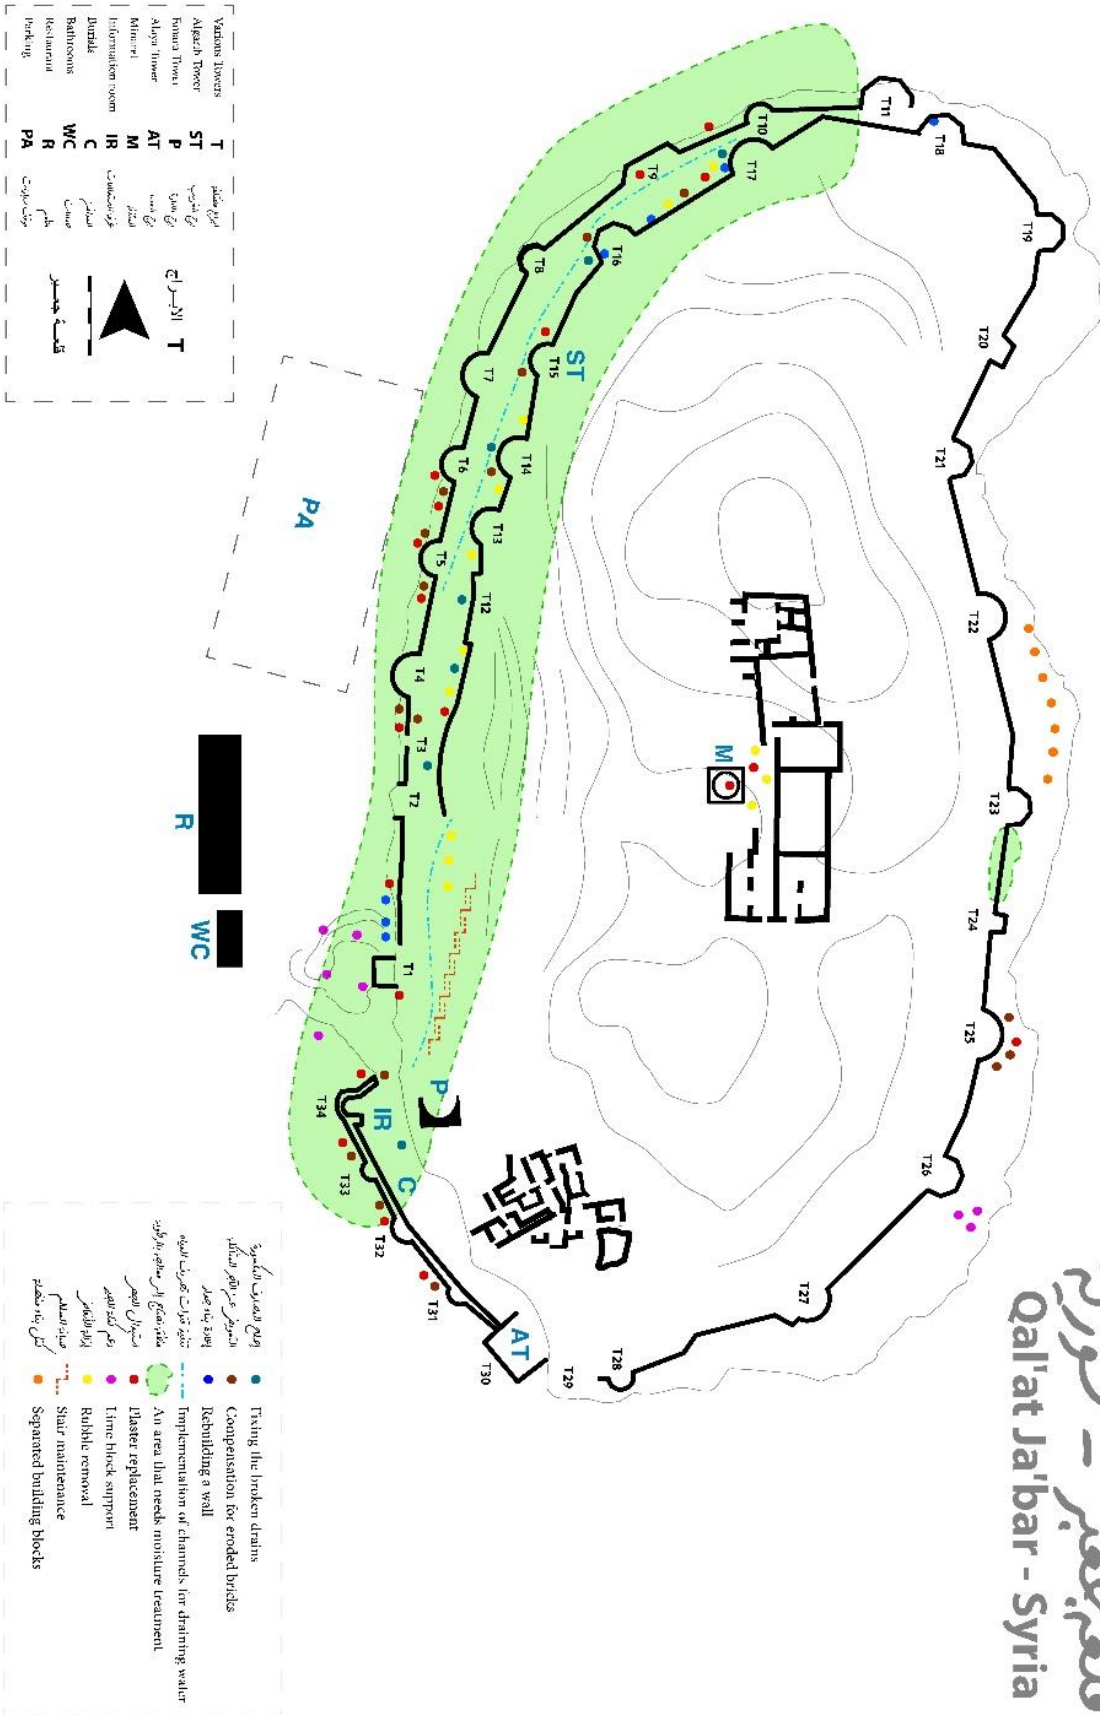
Damage chart in Ja'bar Castle

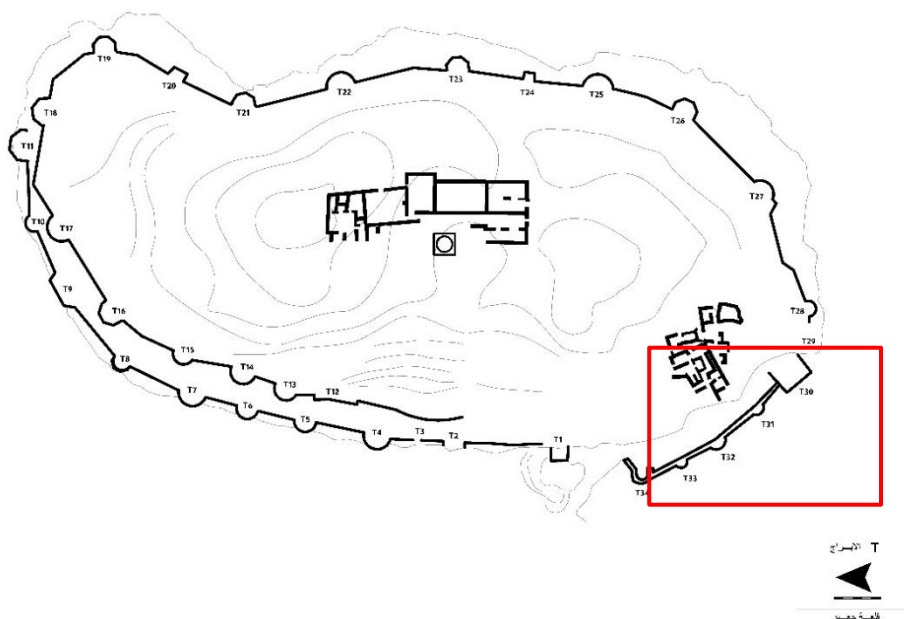
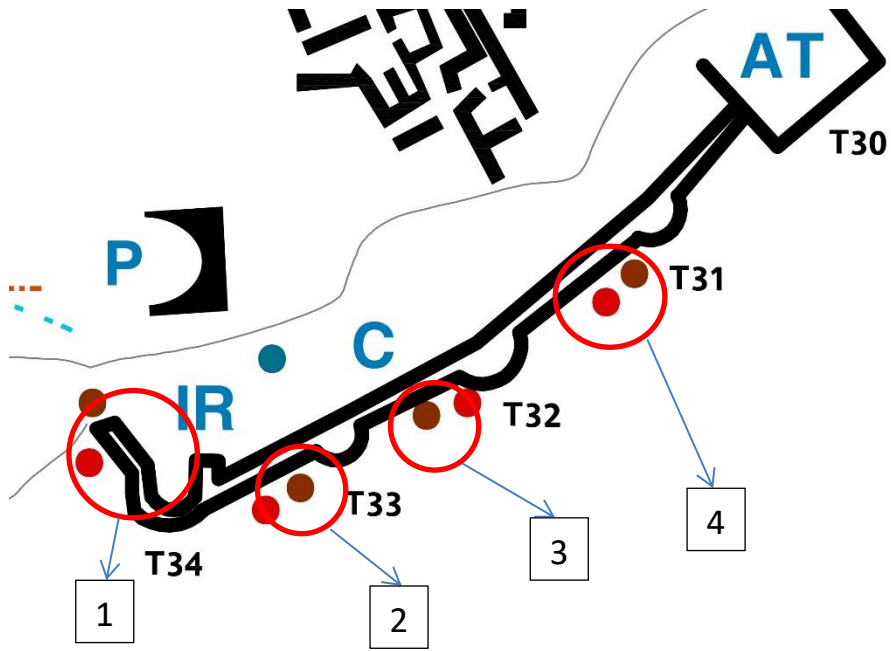
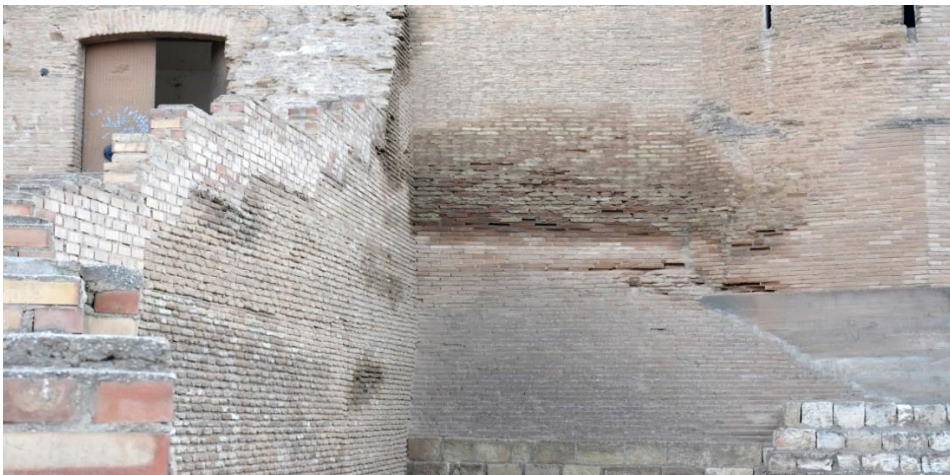
High humidity eroded the brick and fragmented the bonding material. The corrosion of the mortar is estimated at about 40% of the wall area, while the erosion of parts of the wall-shaped brick is about 45-50%.

The general condition of the wall is estimated to be (minor damage), which is superficial damage without many changes.

As for the exposure of this part to risks, in the event of non-response and treatment and the persistence of moisture in this part, it will, over time, lead to its collapse. This requires a short-term intervention within a year.

Damage at point 1 of the outer wall to the right of the main gate

- Treating the cause of dampness by opening and fixing broken drains.
- Replacing the eroded brick.
- Replace the plaster between the brick

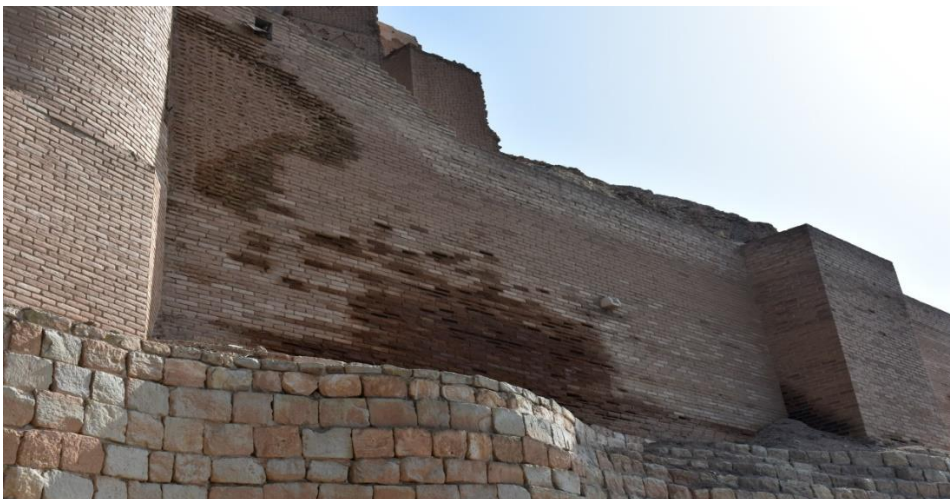
Damage at point 2 of the outer wall to the right of the main gate overlooking the river

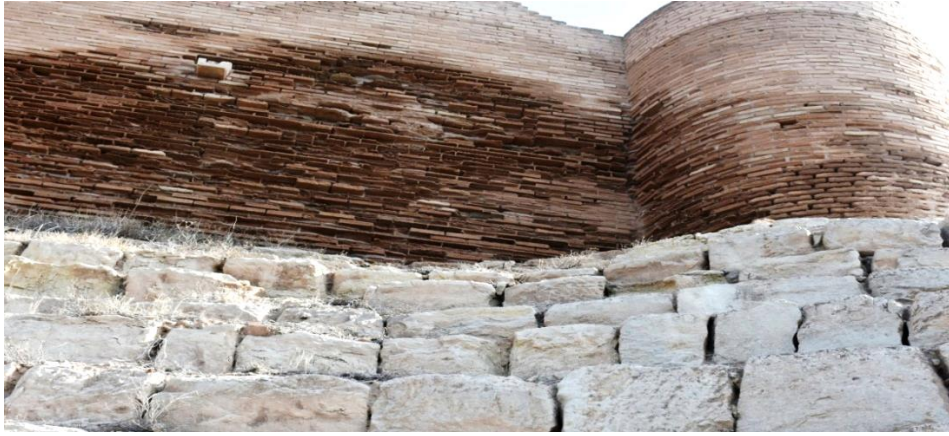
Damage at point 3 of the outer wall

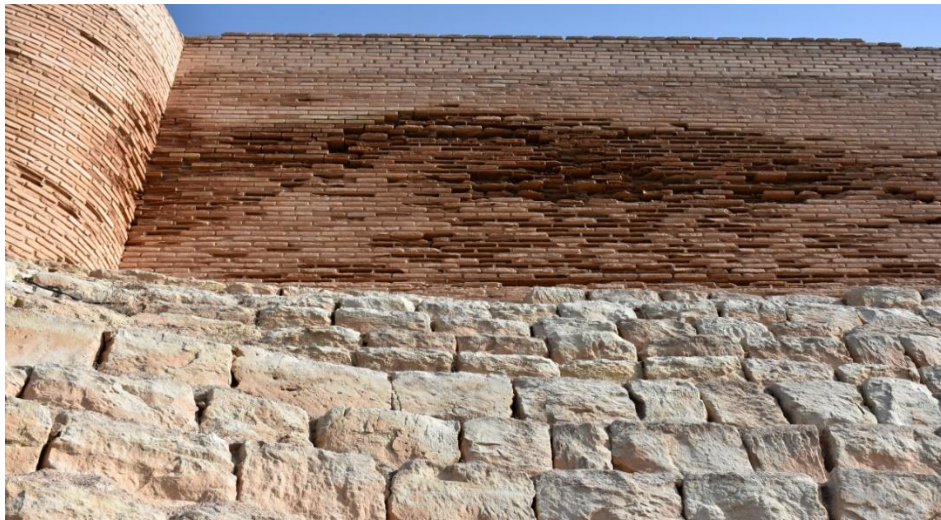
Damage at point 4 of the outer wall

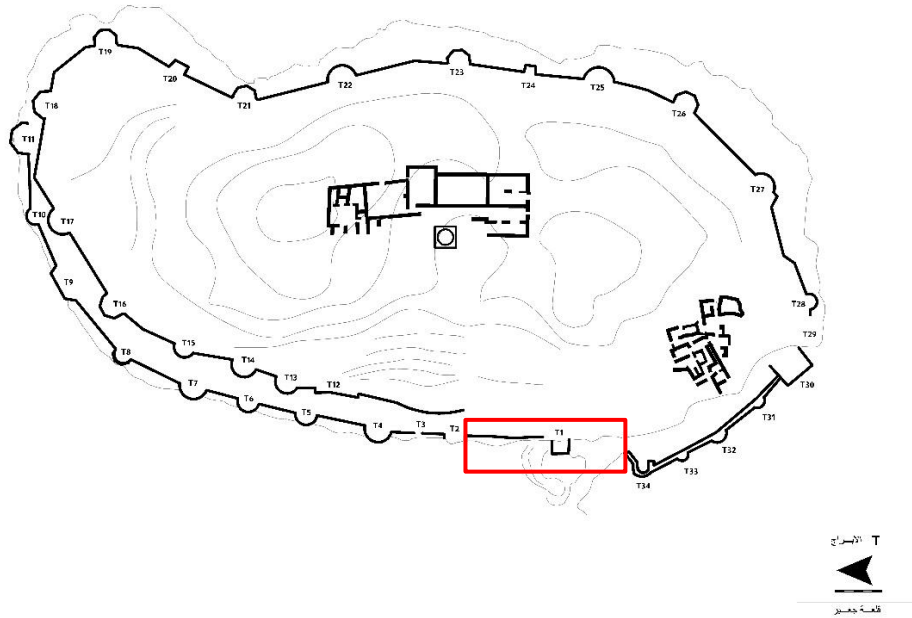
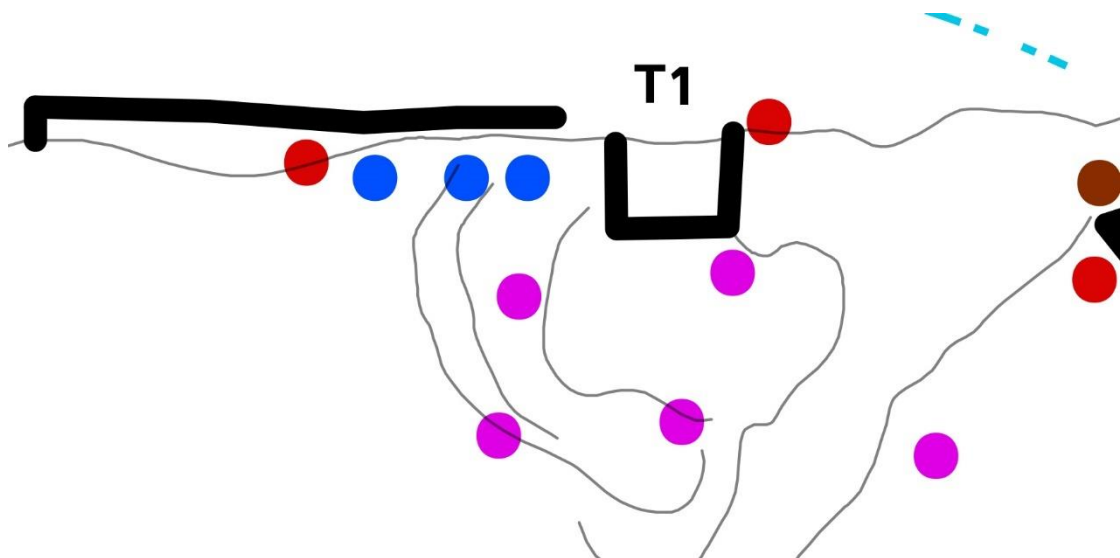
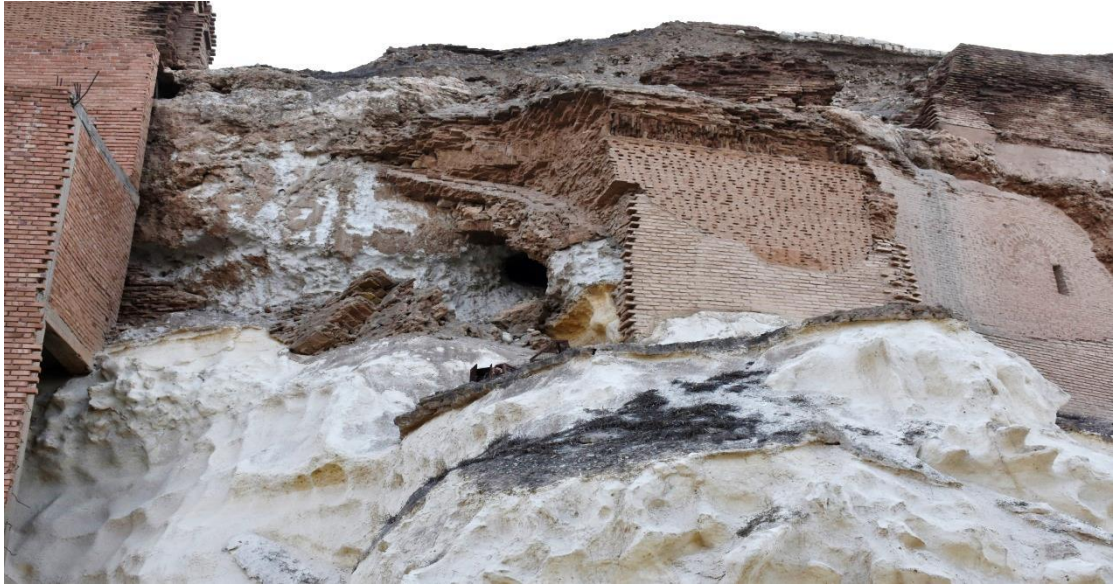
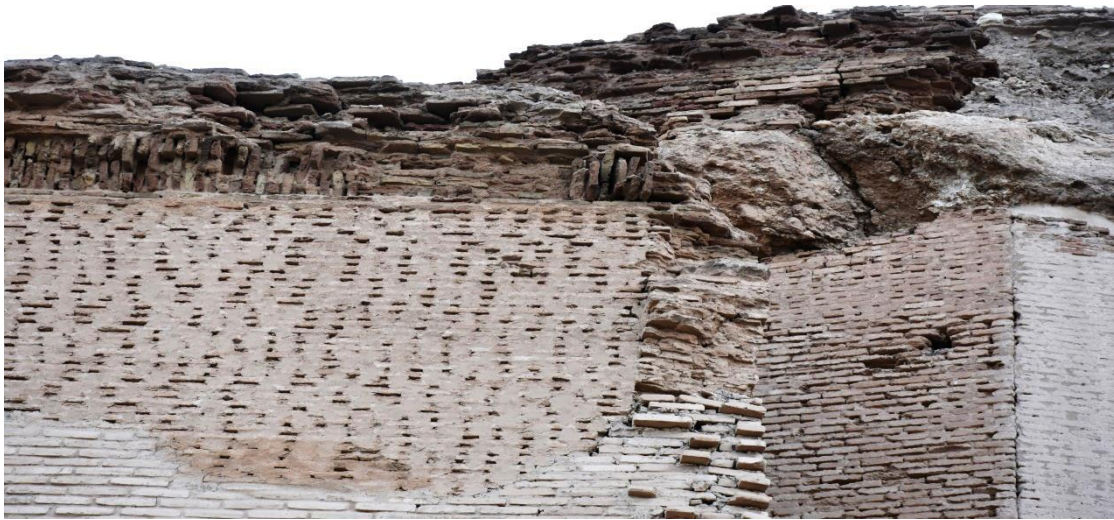
The loss of two blocks of wall as a result of natural factors; it is an unstable mass as a result of the loss of connectivity with the rest of the wall. The situation is also estimated to be severely damaged by the loss of two blocks from the beginning of the wall linking the towers, but the danger is structural, leading to the collapse of the rest of the wall and the dredging of the dirt and the cliff supporting it. This requires necessary intervention of no more than six months.

Damage point of the outer wall from the emirate Tower to the first tower

- Rebuilding the wall between the two towers.
- Support the limestone blocks behind the fence.

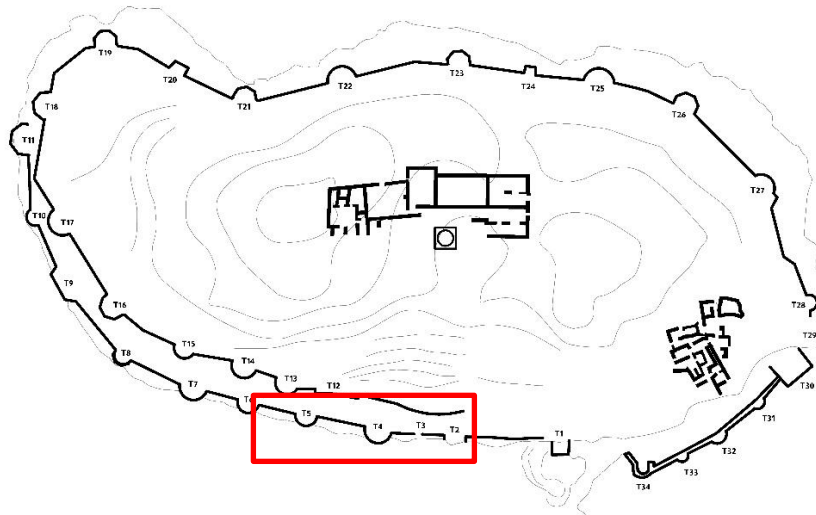
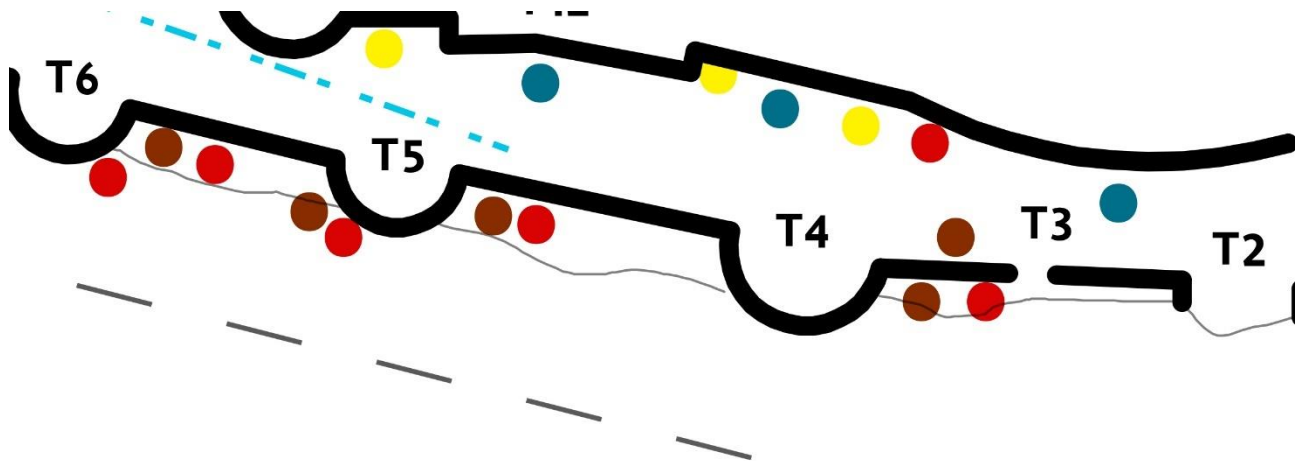
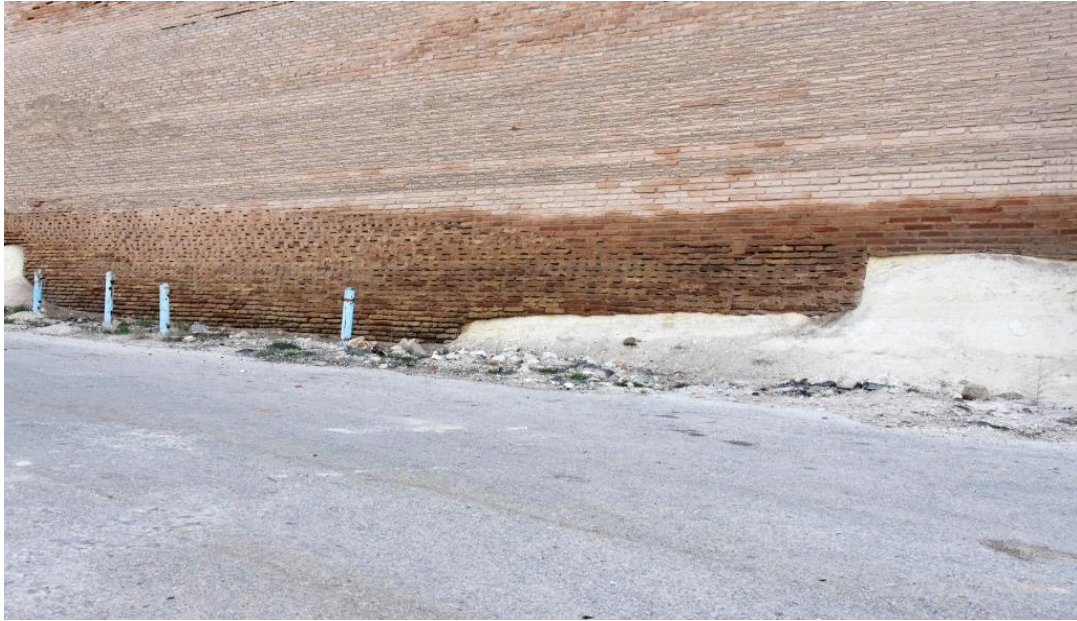
High humidity that led to the erosion of bonding materials and bricks because of digging work below the outer wall resulting in the pool of water below the wall.

The amount of damage is estimated at 40% of the joint plaster mortar and 40% of the brick parts forming the wall. However, the general condition of the wall is estimated as (minor damage), which is temporary surface damage. It is more destructive if it is not treated. Where moisture will persist, and this will lead to the collapse of the wall over time. This requires an intervention within one year.

Humidity in the face down the wall and towers from the first to the fourth towers of the outer wall

- Treating the cause of dampness by opening broken drains.
- Replacing the eroded bricks.
- Replace the plaster between the bricks

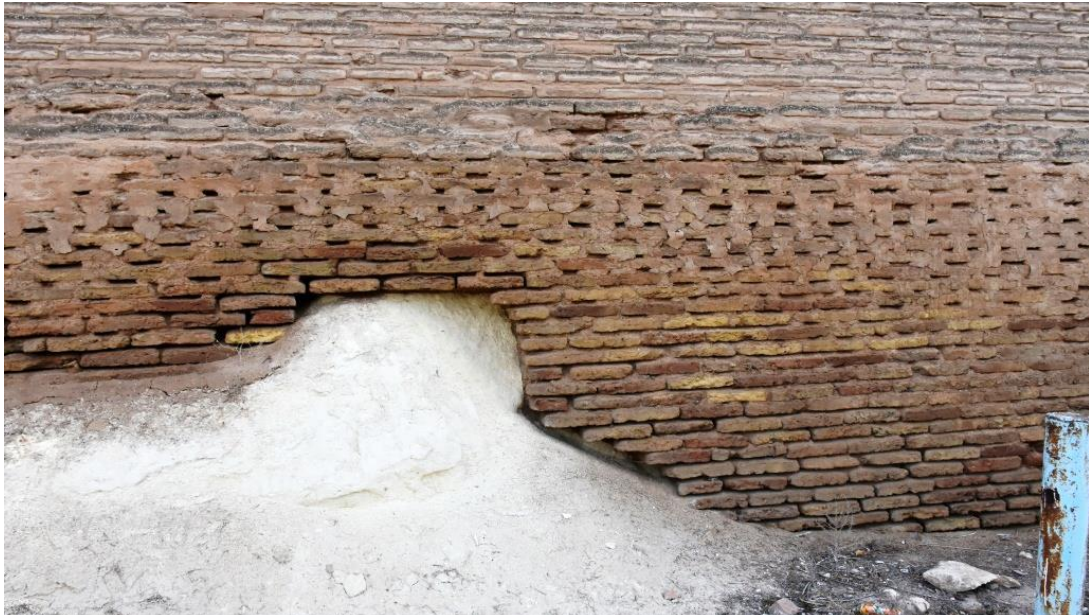
Moisture at the bottom of the wall from the first tower to the fourth tower is eroding the bond between the bricks

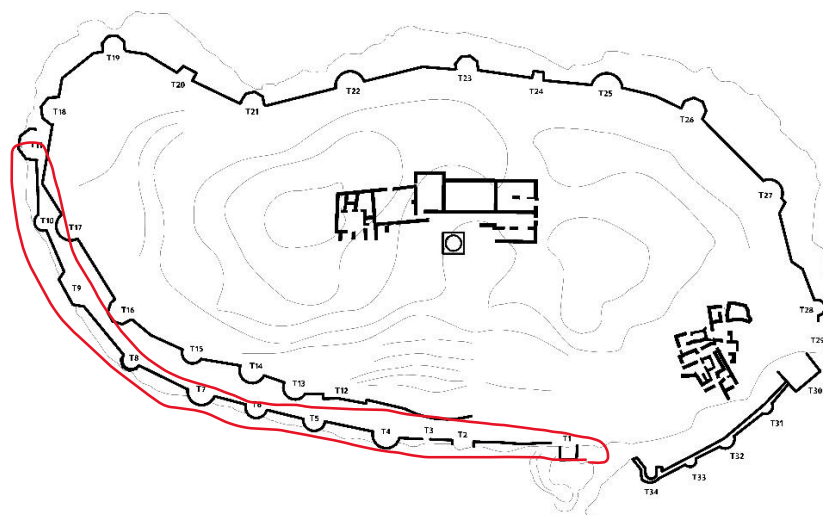
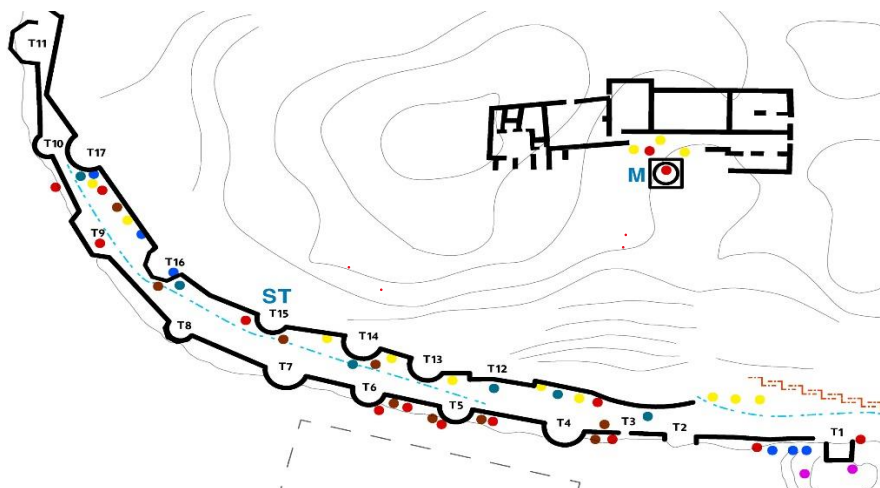
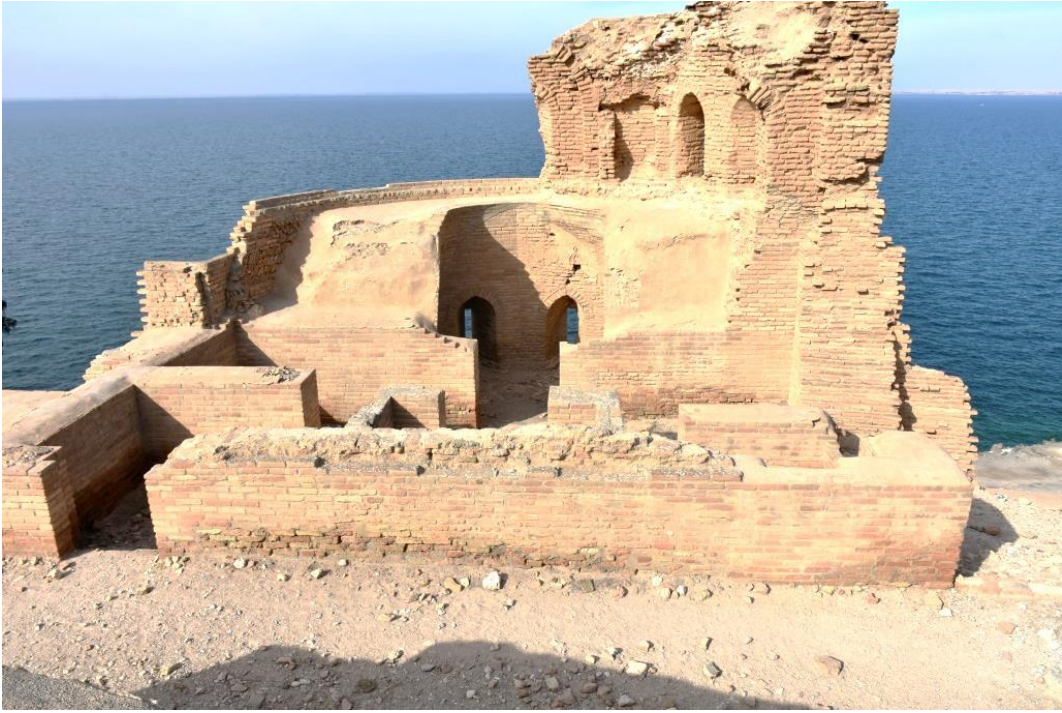
- 60% total loss of building surfaces above towers.
- 40% partial loss of bricks at a distance of 1 m due to natural factors of moisture and exposure led to the erosion of the plaster matter linking the bricks.
- 70% loss and fall of plaster covering the roofs of the arches. This requires necessary intervention of no more than six months.

General view of one of the towers of the inner wall of the castle T5

- Address the cause of moisture by opening broken drains on the castle surface in the corridors, removing debris and leveling floors.
- Repair for corroded bricks.
- Replace the plaster between the bricks and cover the surfaces with a plaster layer.

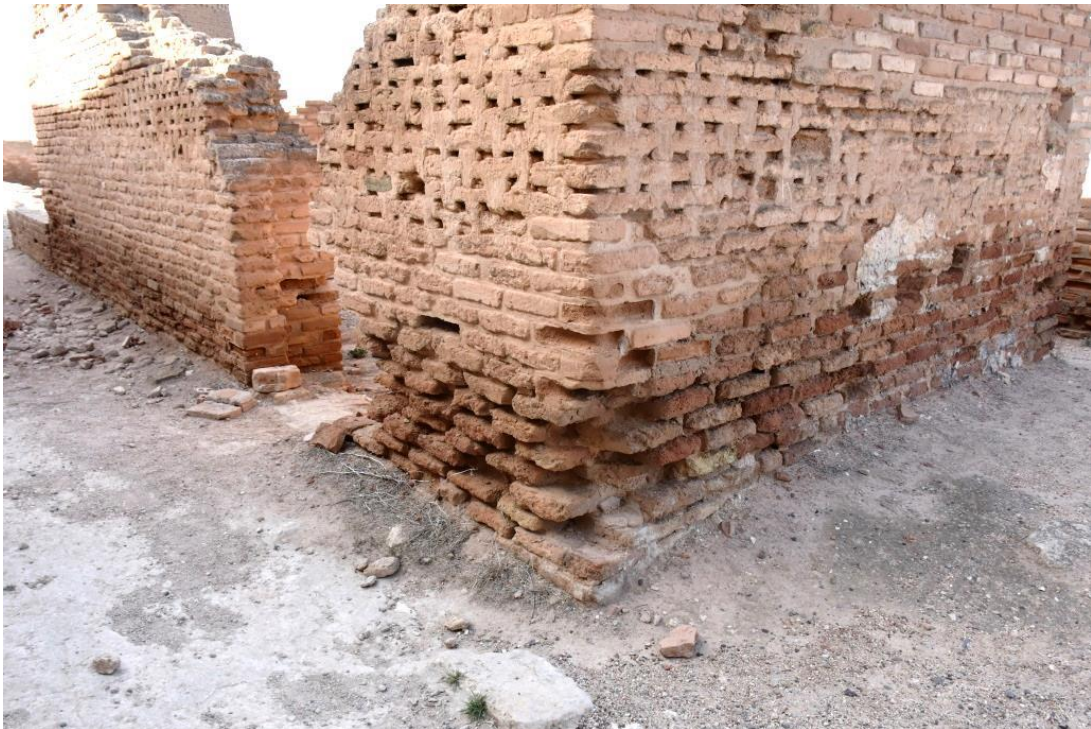
Brick erosion in the corner of buildings attached to the towers of the outer wall

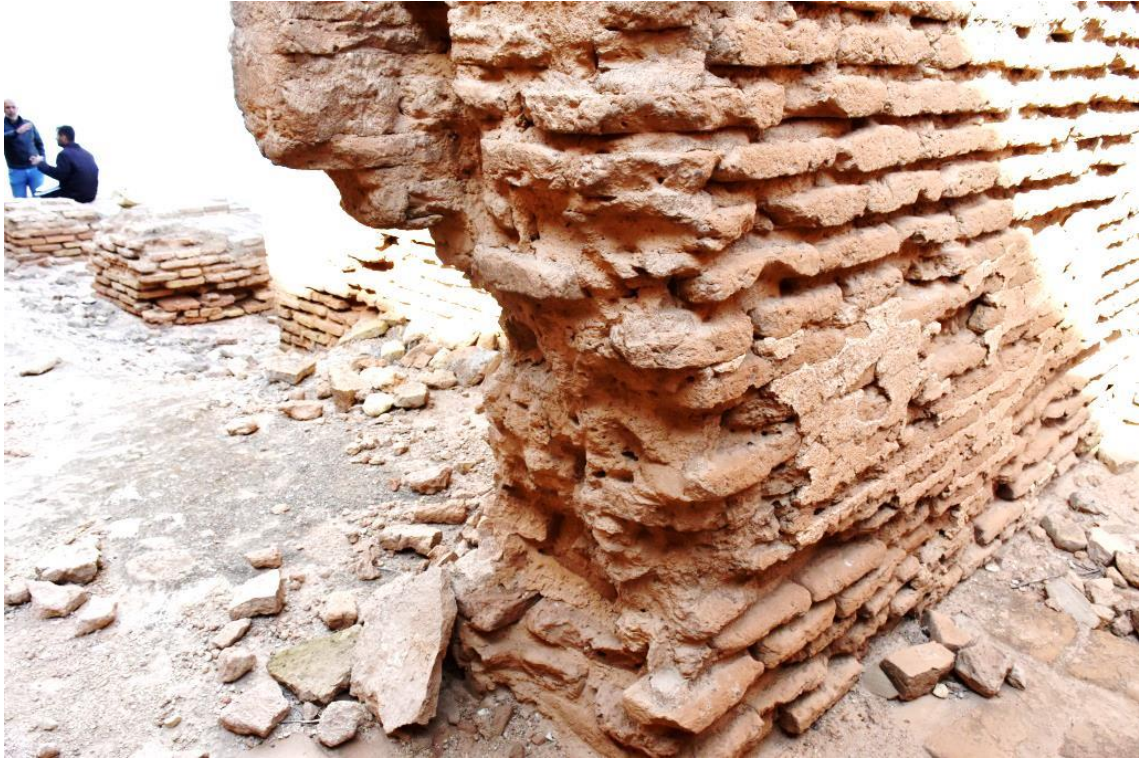
Corrosion and loss of bricks in the buildings attached to the towers of the outer wall

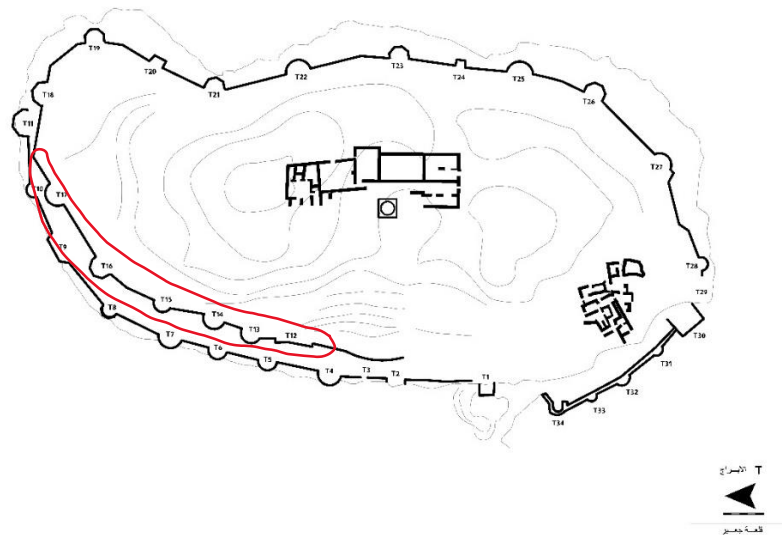
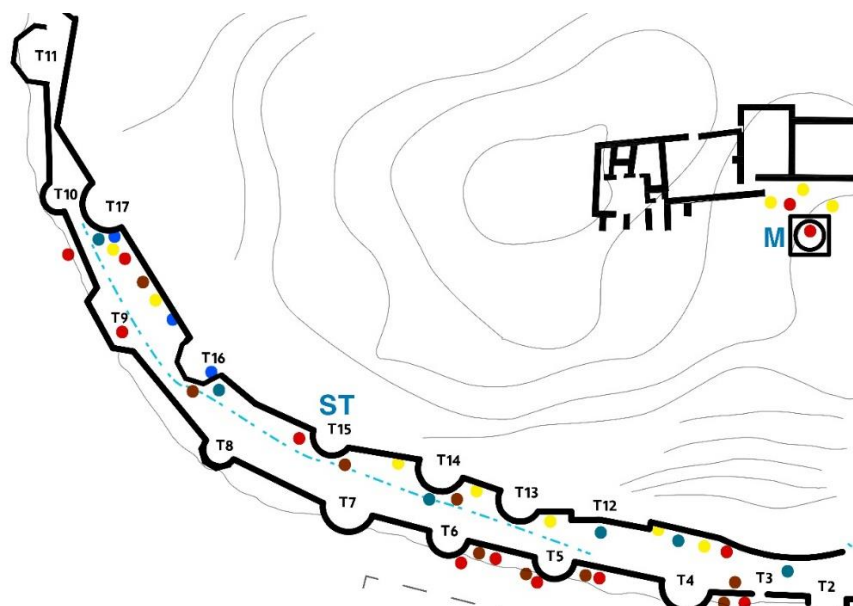
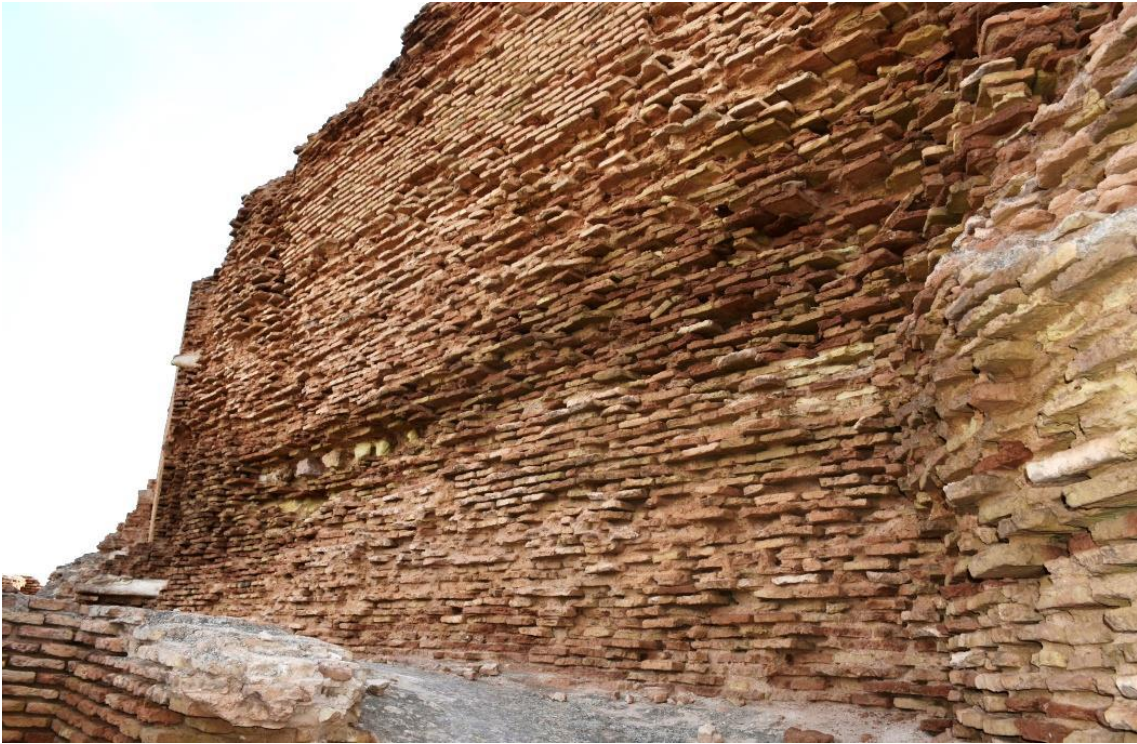
- Loss of part of the inner wall.
- Loss of parts of the brick's component of the wall, 70 cm thick over the height of the wall 6 m and the length of 60 m.
- The disintegration and separation of part of the wall from the mass based on it because of natural conditions.
- A superficial loss of plaster bonding between the brick buildings formed by the body of the wall.

The size of the loss of bricks in this part of the fence (from Tower 12 to Tower 18) is estimated at 60 m. The risk of crumbling bricks in most of the towers is 40%, in the event of non-treatment, continued humidity and weather factors and the

disintegration of the limestone mass supporting the wall. This will lead over time to the collapse of the wall, which will destroy parts of the outer wall.

Loss of brick in one of the walls of the inner wall.

- Dismantle the separated parts and rebuilt them.
- Replace the missing bricks in the wall with the implementation of bonding supports within the old mass to increase cohesion and protect surfaces with a layer of plaster.
- Replace the lost plaster among the bricks
- Implementation of drainage channels at the top of walls to prevent water penetration.
- Remove debris at the bottom of walls and level corridors to prevent water pooling.

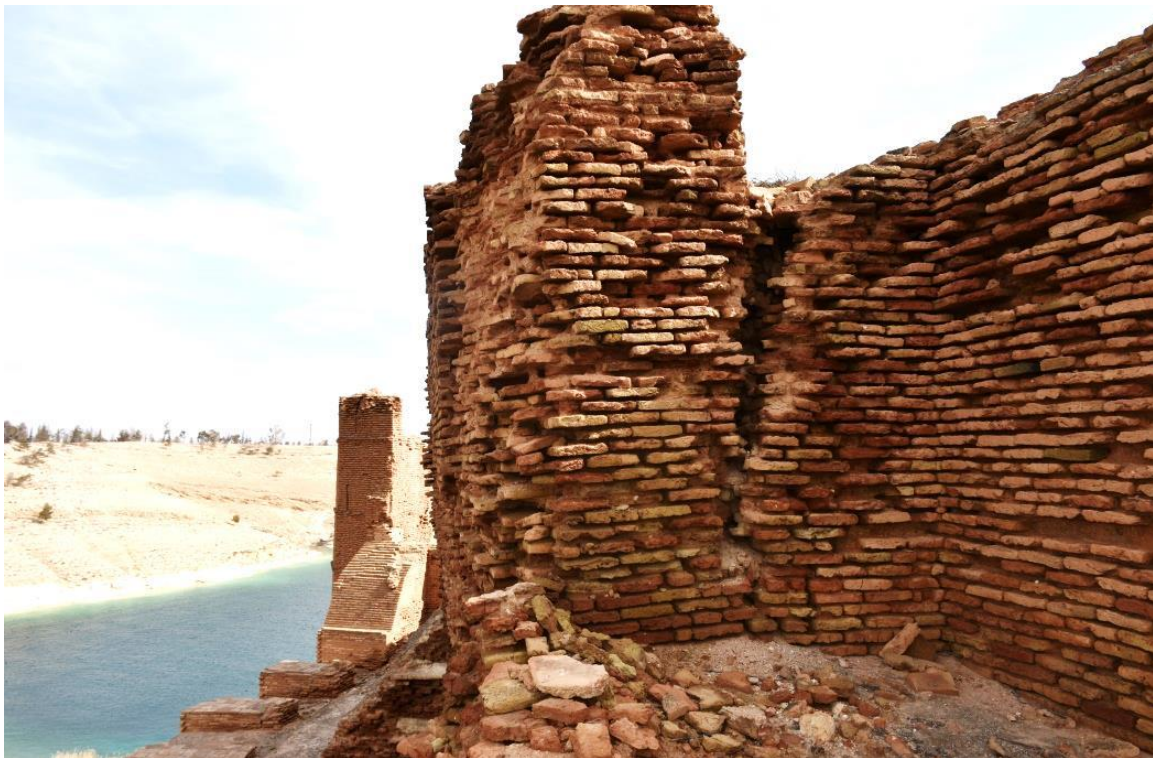
A separated block of the inner wall of the castle.

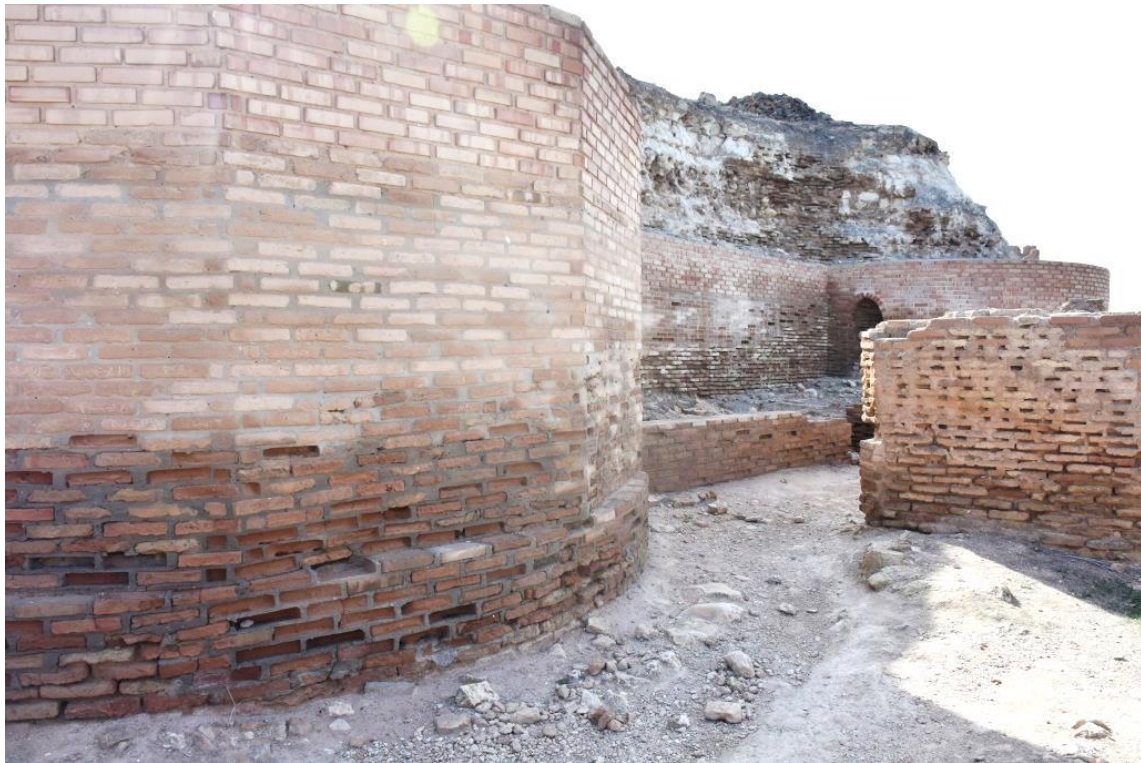
Erosion of the bricks in the tower of the inner wall of the castle

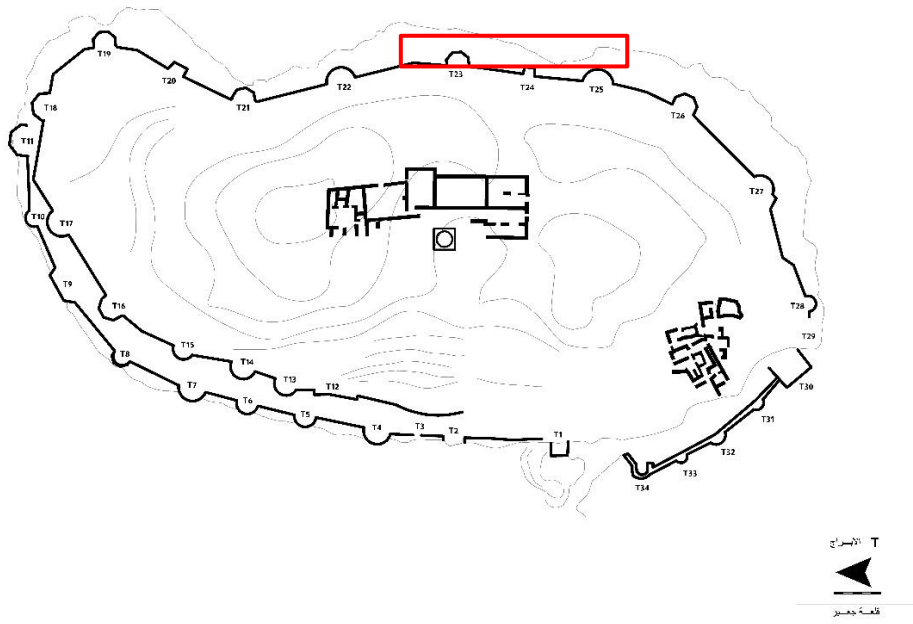
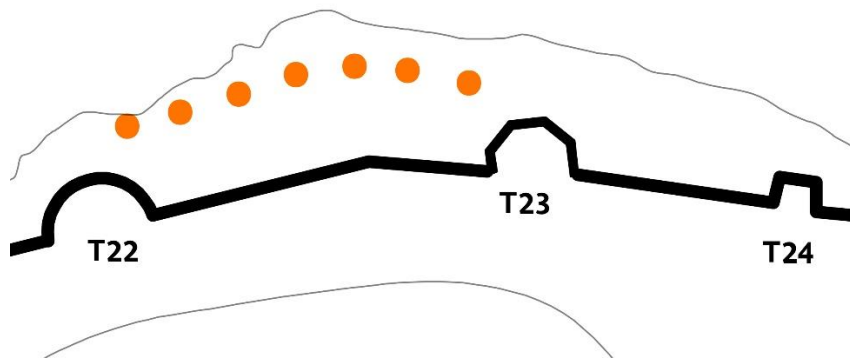
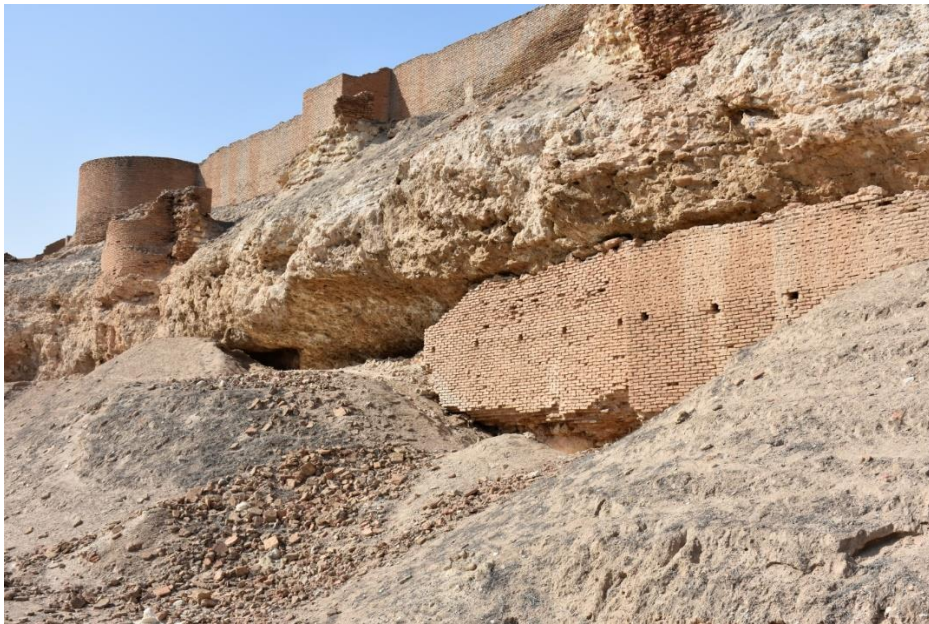
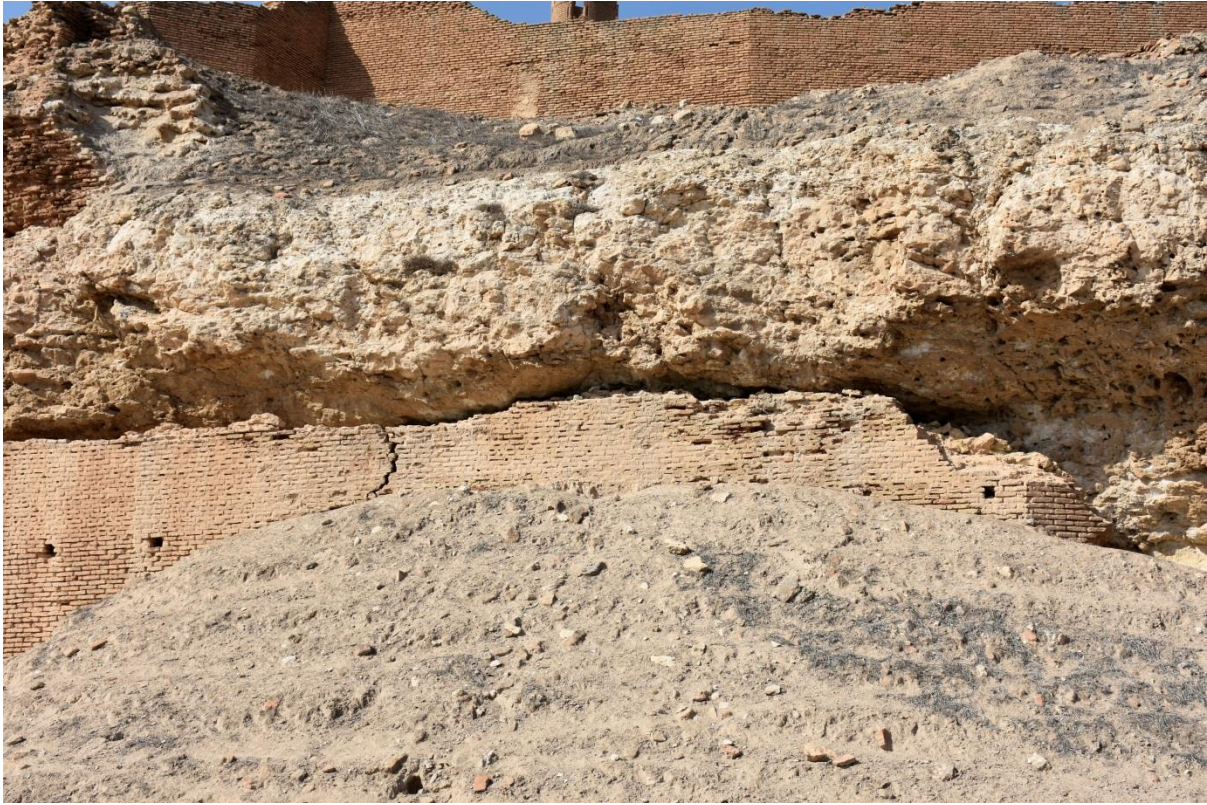
This damage is the separation of the building block of the outer brick wall in the confined area between towers T22-T24 (as the bulk of the outer wall collapsed over time).

- Connect the building block to the rock base with wooden pillars (Khoabir).
- Inject the spaces formed behind the outer wall.
- Level the area between the walls to facilitate the drainage of rainwater into the lake.
