# Qalaat Ja'bar Report 2022

## Historical and Archaeological Study, Damage Assessment, Current Situation, Stabilization, and Proposed Restoration

Presented by: Khaled Hiatlih - Yasser Shauhan - Ristom Abdo

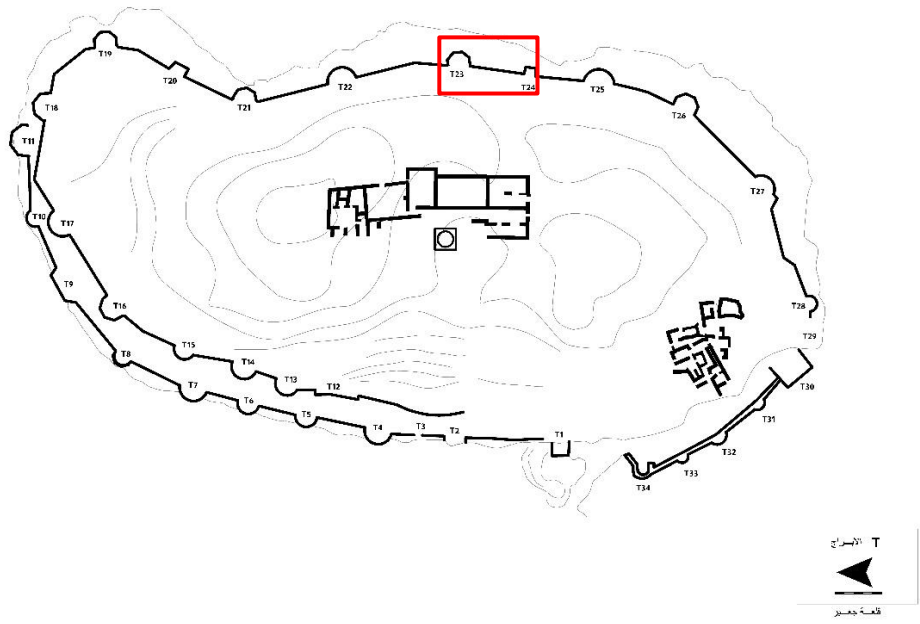
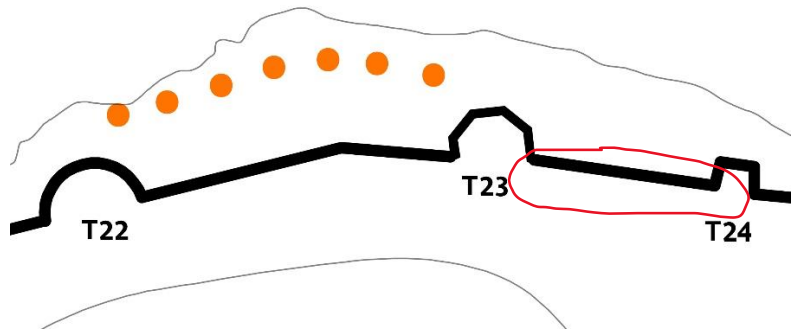
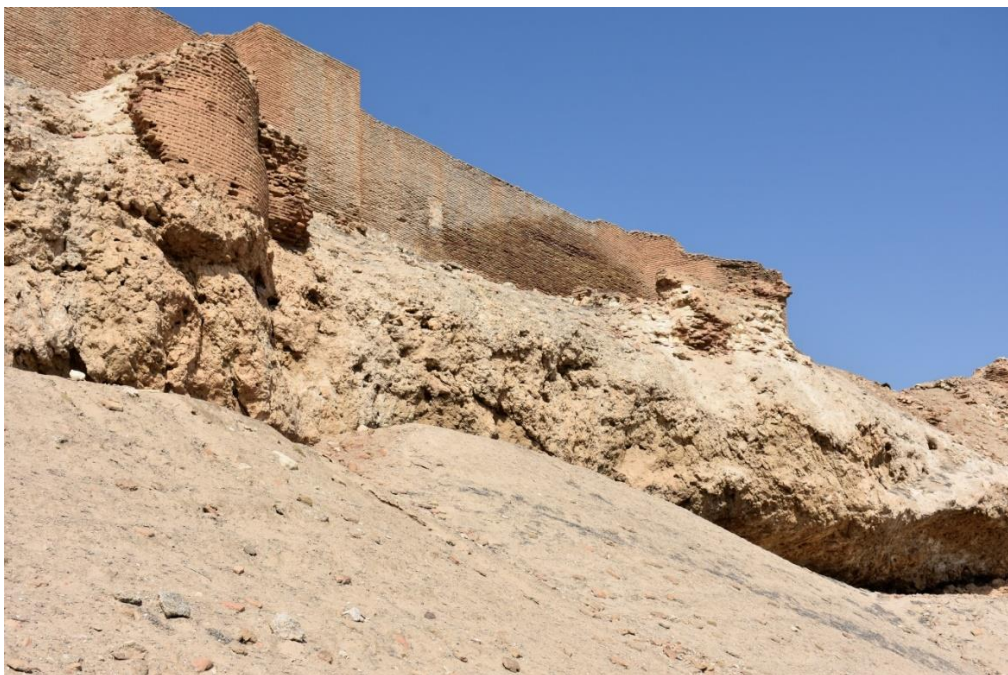
High humidity has led to the erosion of bonding materials and bricks as a result of losing the base below the outer wall resulting in the pooling of water below the fence.

The amount of damage is estimated at 20% of the mortar and 20% of the brick parts of the wall. The general condition of the wall is estimated to be (minor damage), which is temporary surface damage.

- Carry out drainage work below the area between the towers 23-24 from the inside.
- Replace corroded bricks with new bricks.
- Repair for the plaster.

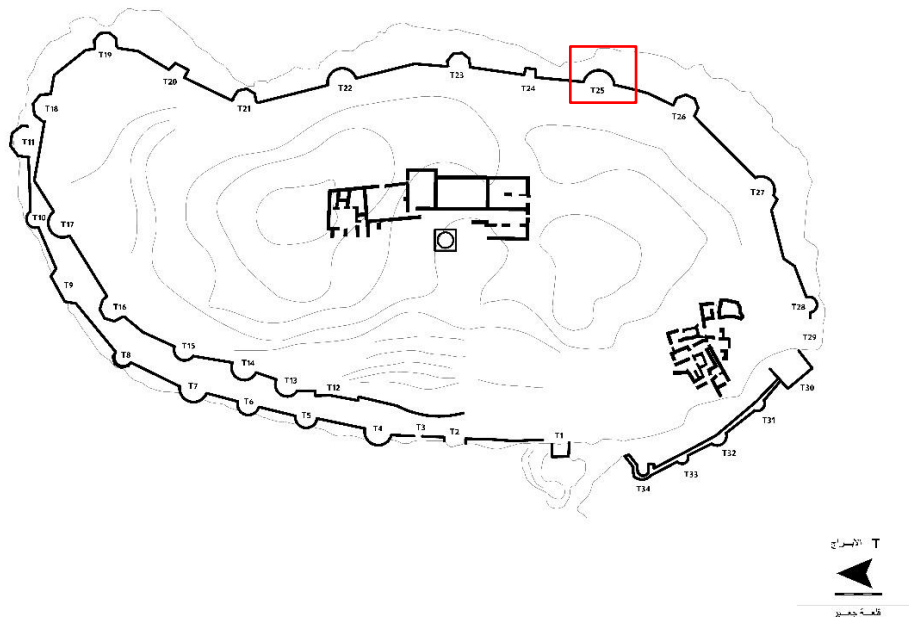
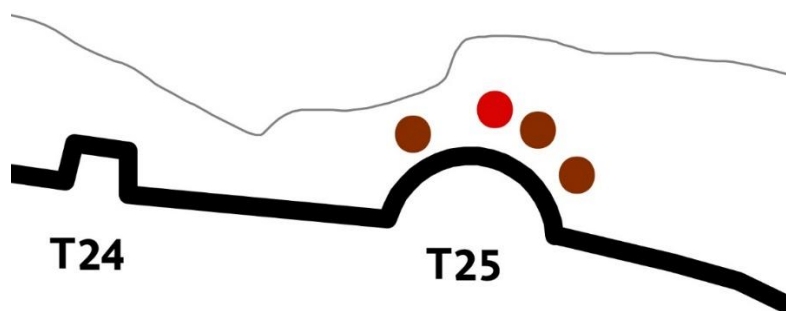
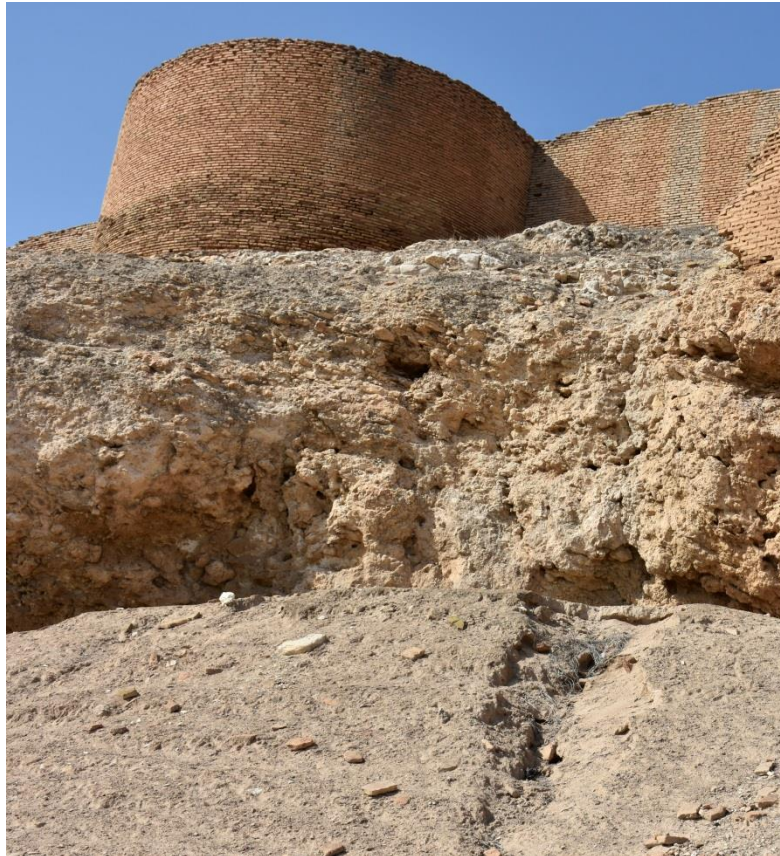
The bricks fall, erode, and crumble horizontally, indicating that amounts of rainwater are stored inside the tower.

- Carry out drainage work below the tower (T25).
- Replace corroded bricks with new bricks .
- Repair for the plaster

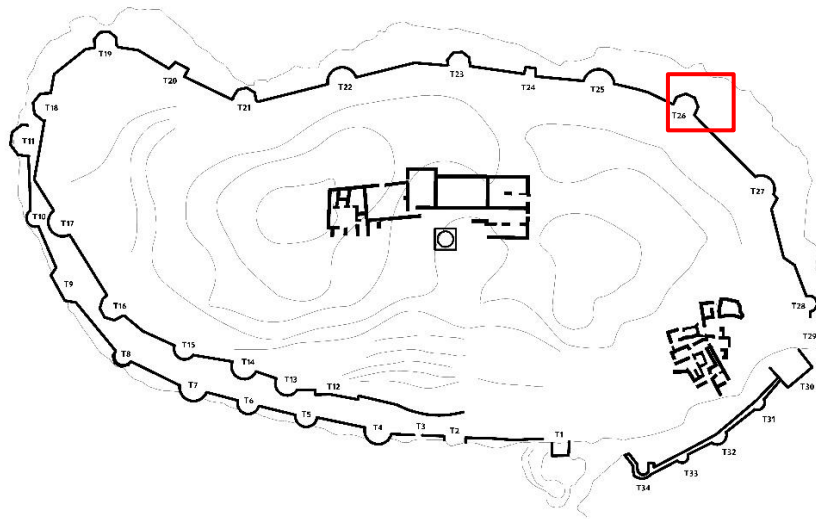
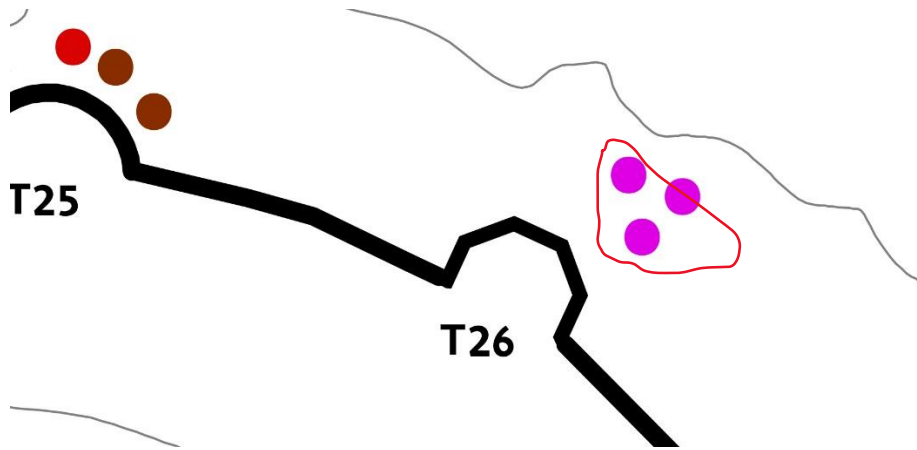
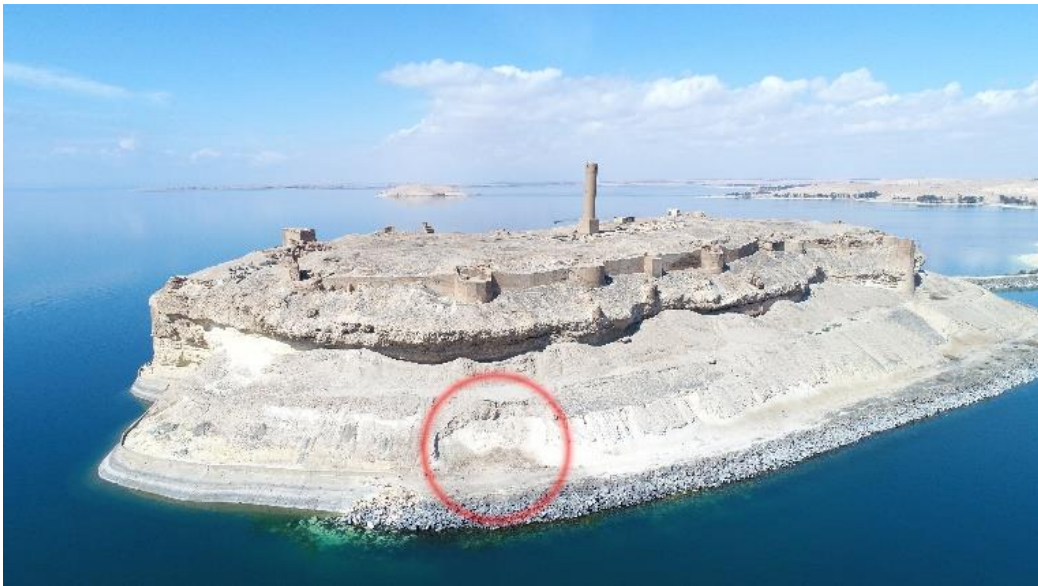
There are erosion and weathering at work below tower 26 on the south-east side of the castle's rock foundation.

- The limestone layer of the rock base is revealed and eroded by wind and water.
- Partial loss of amounts of base-supporting soil below Tower 26, threatening one or more partial collapses.

- Reinforcing the collapsible parts below Tower 26.
- Fill in/or cover the voids created by revealing the soft limestone layer.

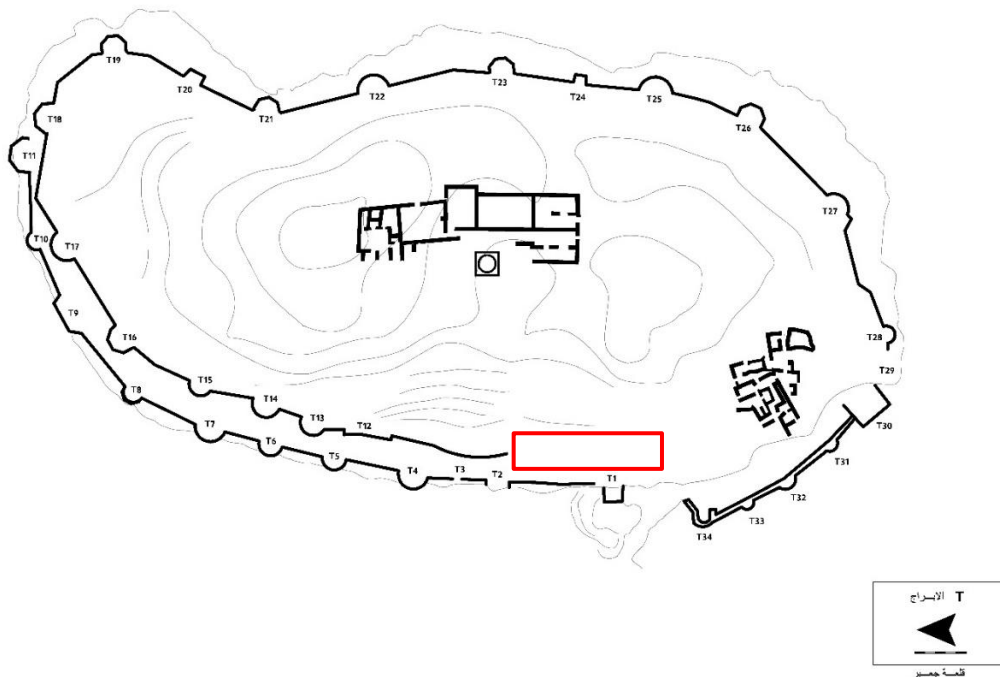
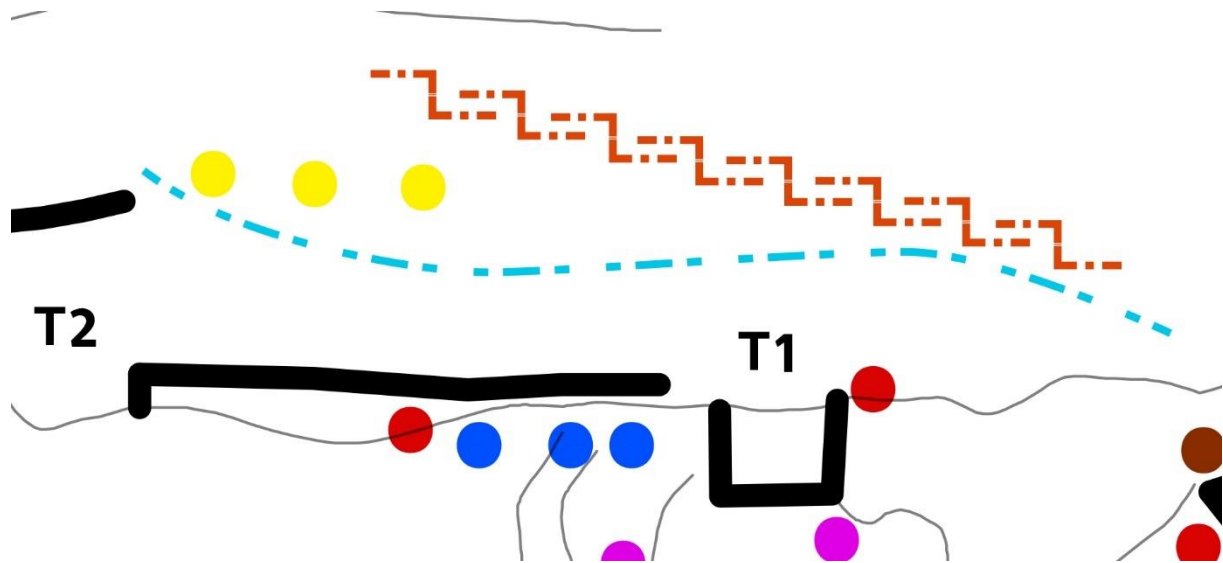
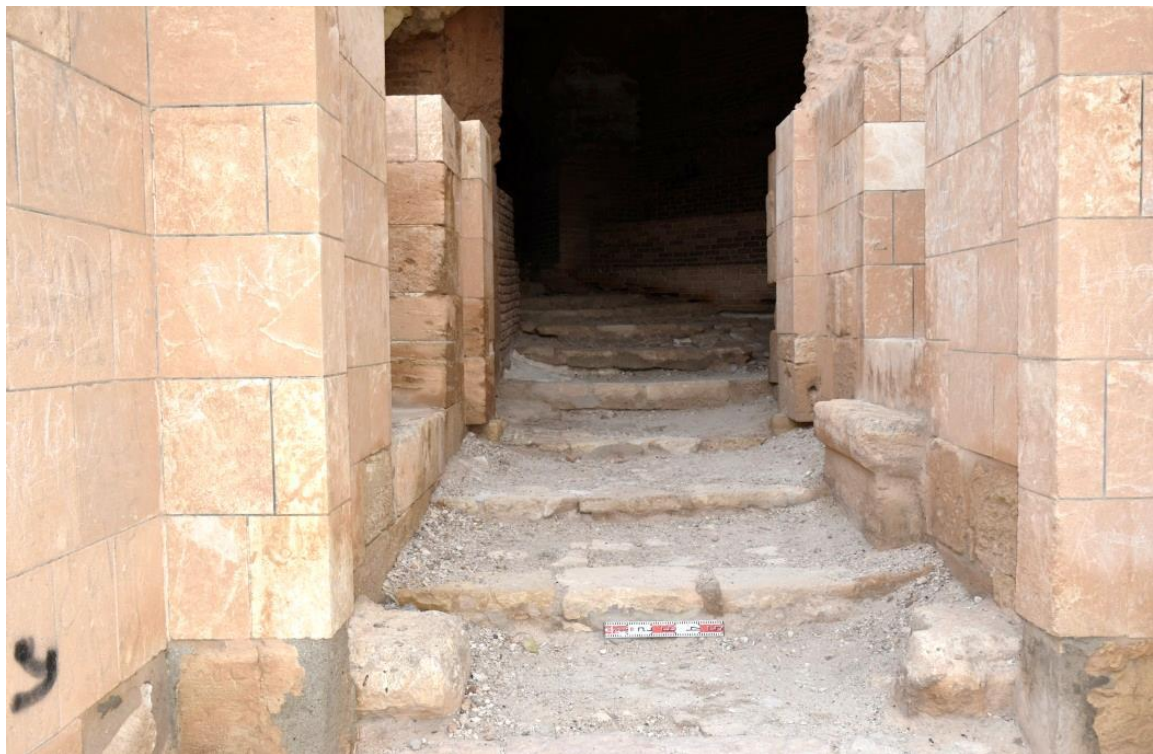
- Erosion of grades as a result of natural factors, rainwater and accumulation of debris within parts of the corridor. Maintenance is necessary for up to two months.
- 20% partial loss of stair structure
- If not maintained, it prevents visitors' access to the site.

Entrance to the tunnel leading to the roof of the castle

- Remove and clean debris from the entrance to the site.
- Processing and implementing rainwater drainage channels.
- Maintenance of the stairs.

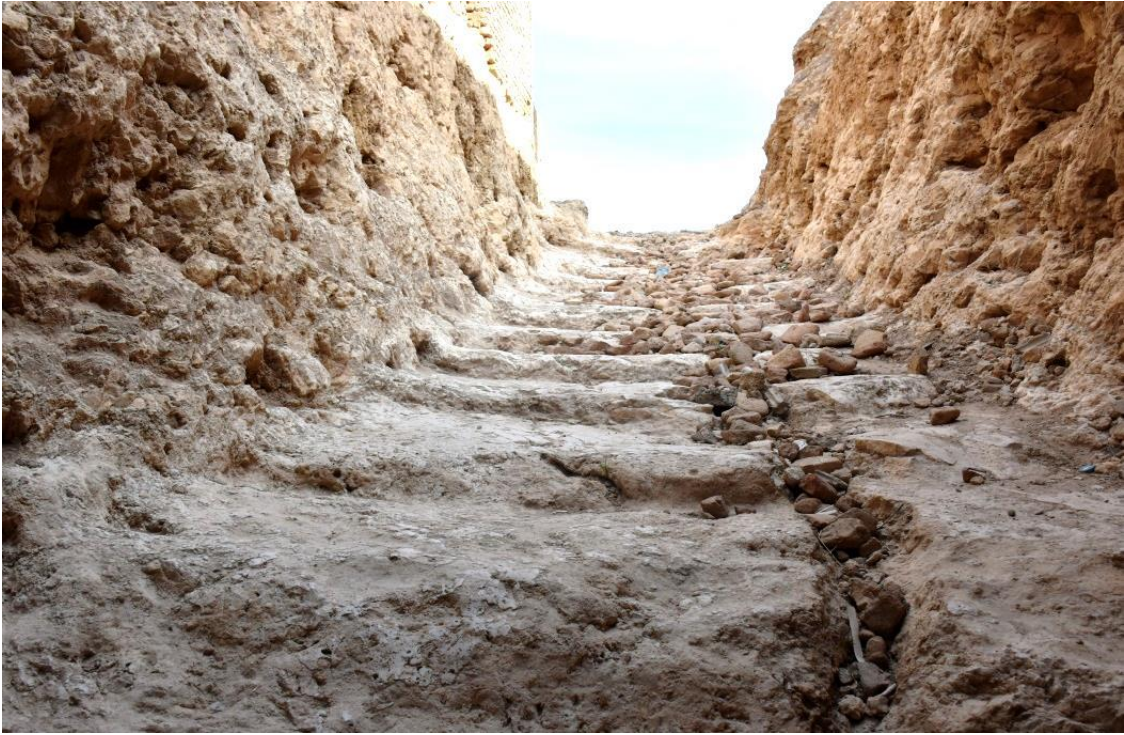
Corrosion in the staircase of the access tunnel to the roof of the castle

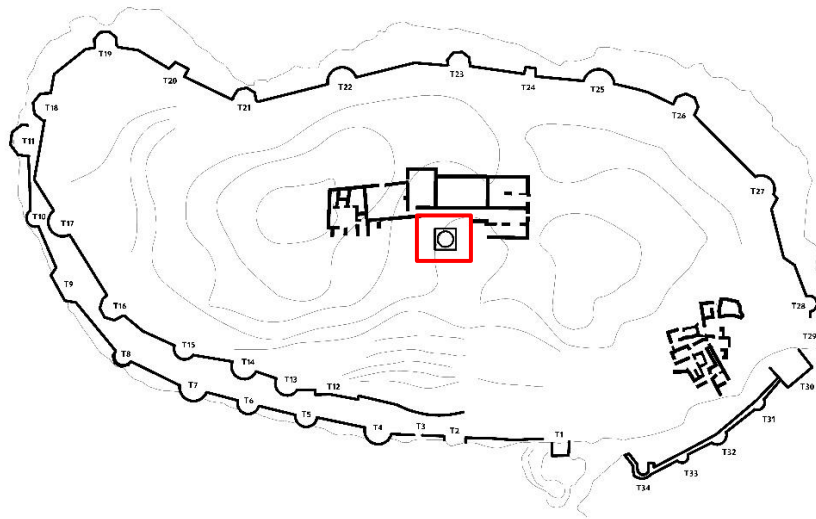
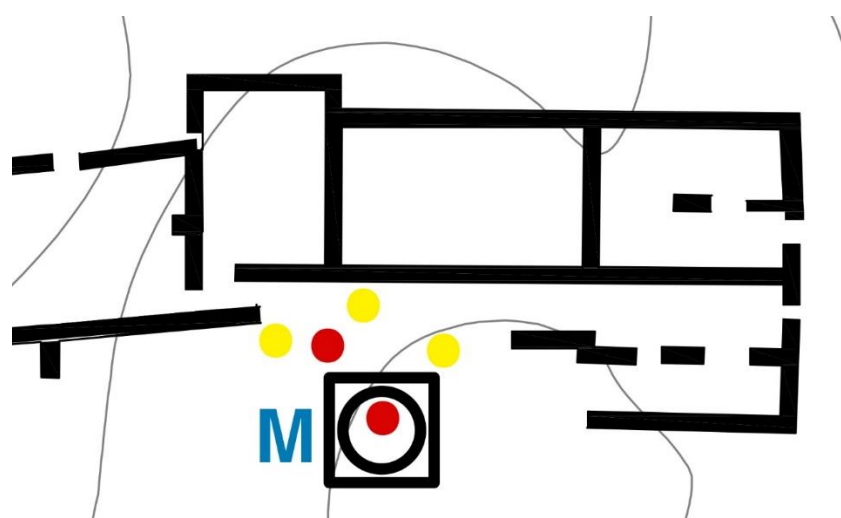
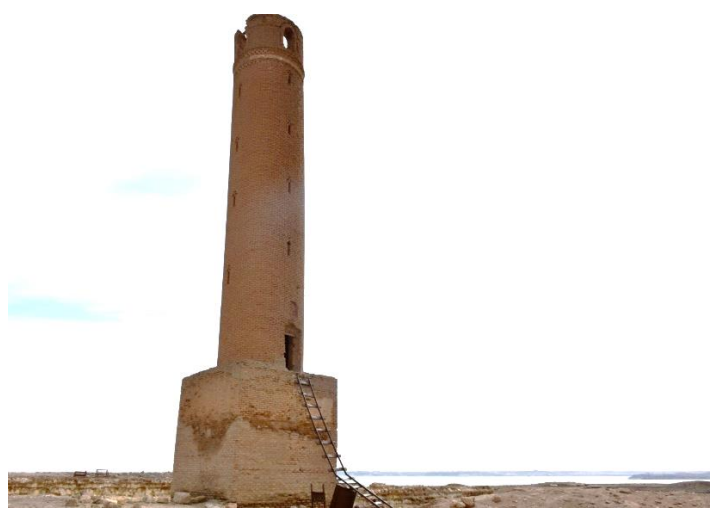
- Deviation in the minaret due to natural conditions with structural stability, with a very low risk ratio (less than 5%).
- Small cracks at the base do not reach the trunk of the minaret.
- Mortar erosion between the brick.

Minaret of The Citadel Mosque

- Remove metal waste or move it from the minaret base.
- Remove the debris around the base and level the perimeter of the base to prevent water gathering around it.
- Apply brown plaster among the brick.

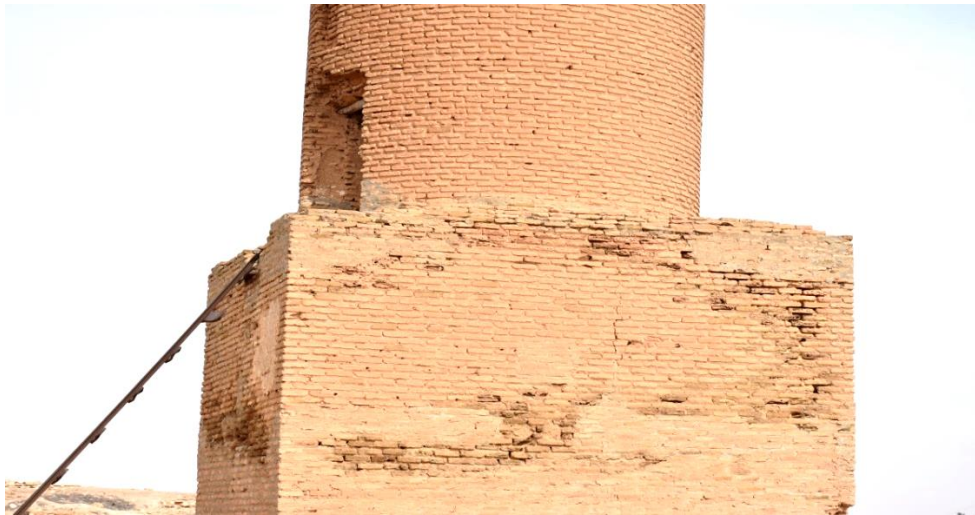
Erosion in the bricks and plaster
