# EARTHQUAKE DAMAGE TO SYRIAN CULTURAL HERITAGE

Damage report / Heritage Roots V.O.F  
DEN HAAG 2023

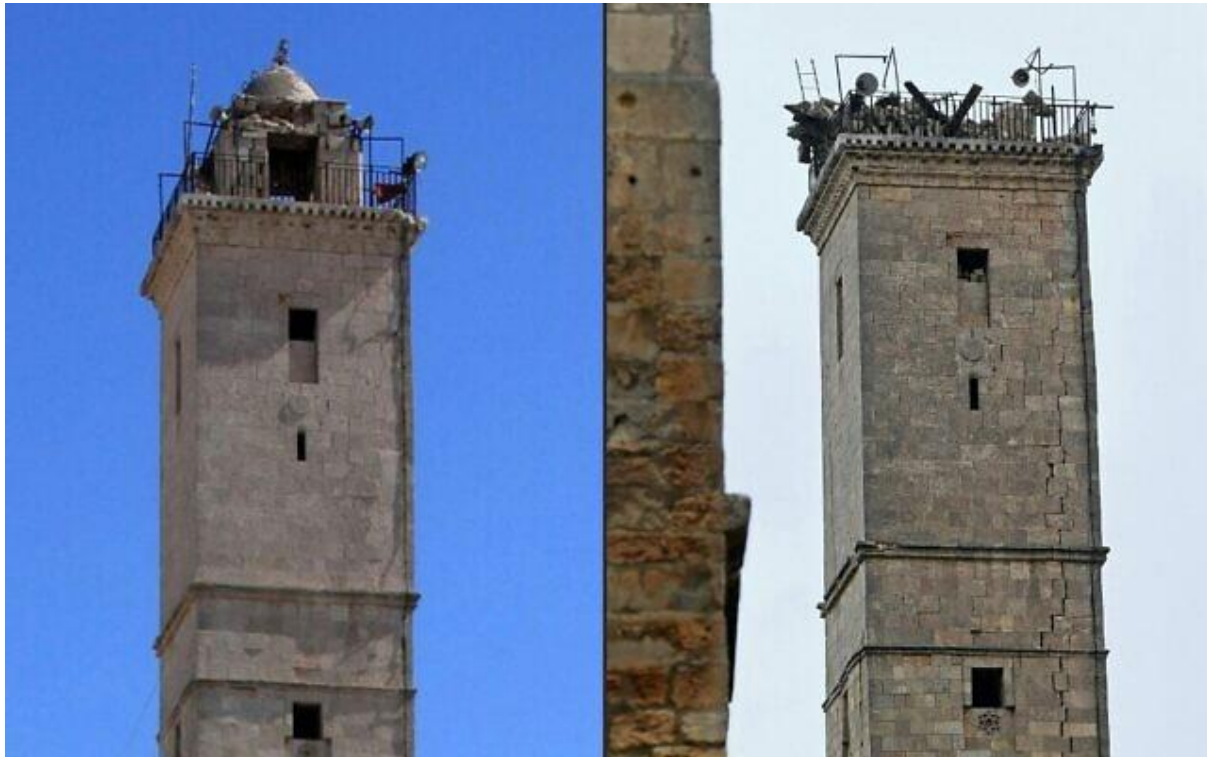
- Parts of the northern, eastern, southern, and western of the barrack roof was also damaged.
- long cracks in the facades of the Ayyubid mosque minaret in the citadel, and the collapse of its spire.

Aleppo Citadel -Damaged for Minaret of the mosque inside of the UNESCO-listed citadel, February 6, 2023, following an earthquake (AFP)

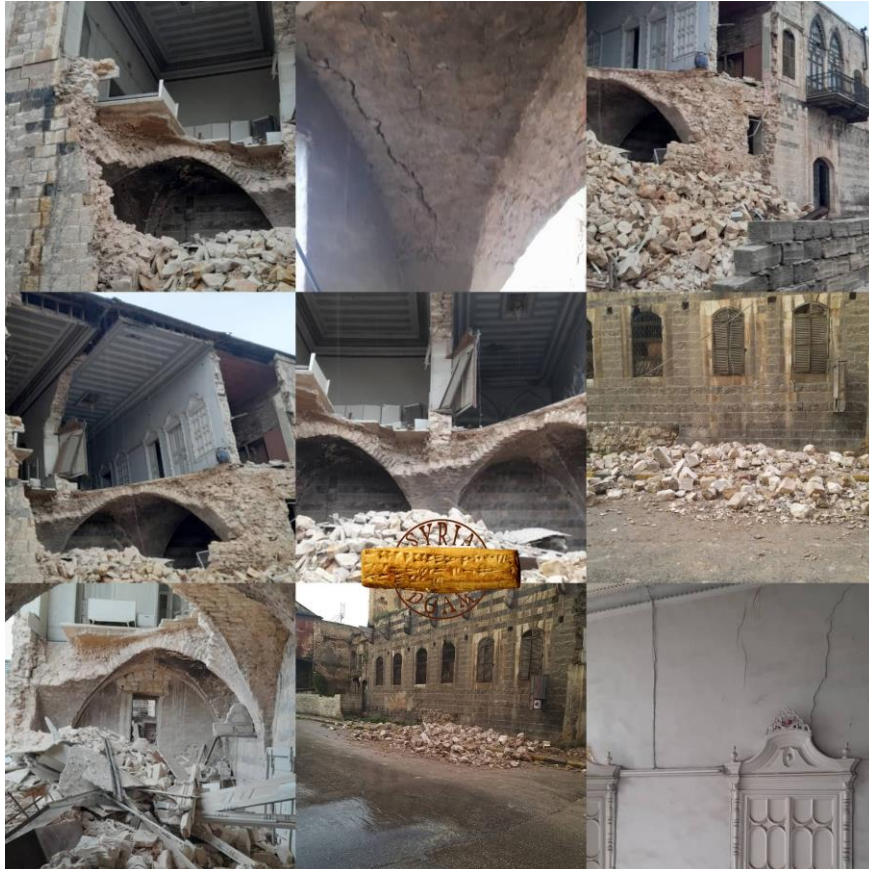
cracks occurred in the facades and walls of many heritage buildings, which led to the fall parts of the facades of these buildings, the most affected building is heritage property (Al-Jalaa segment), 9m<sup>2</sup> which totally damaged.

Huge damage and cracks in the façade of heritage building no.982, located in the neighborhood of Al-Bashoura.

Hama, Heritage building damaged - February 6, 2023, following an earthquake (DGAM)

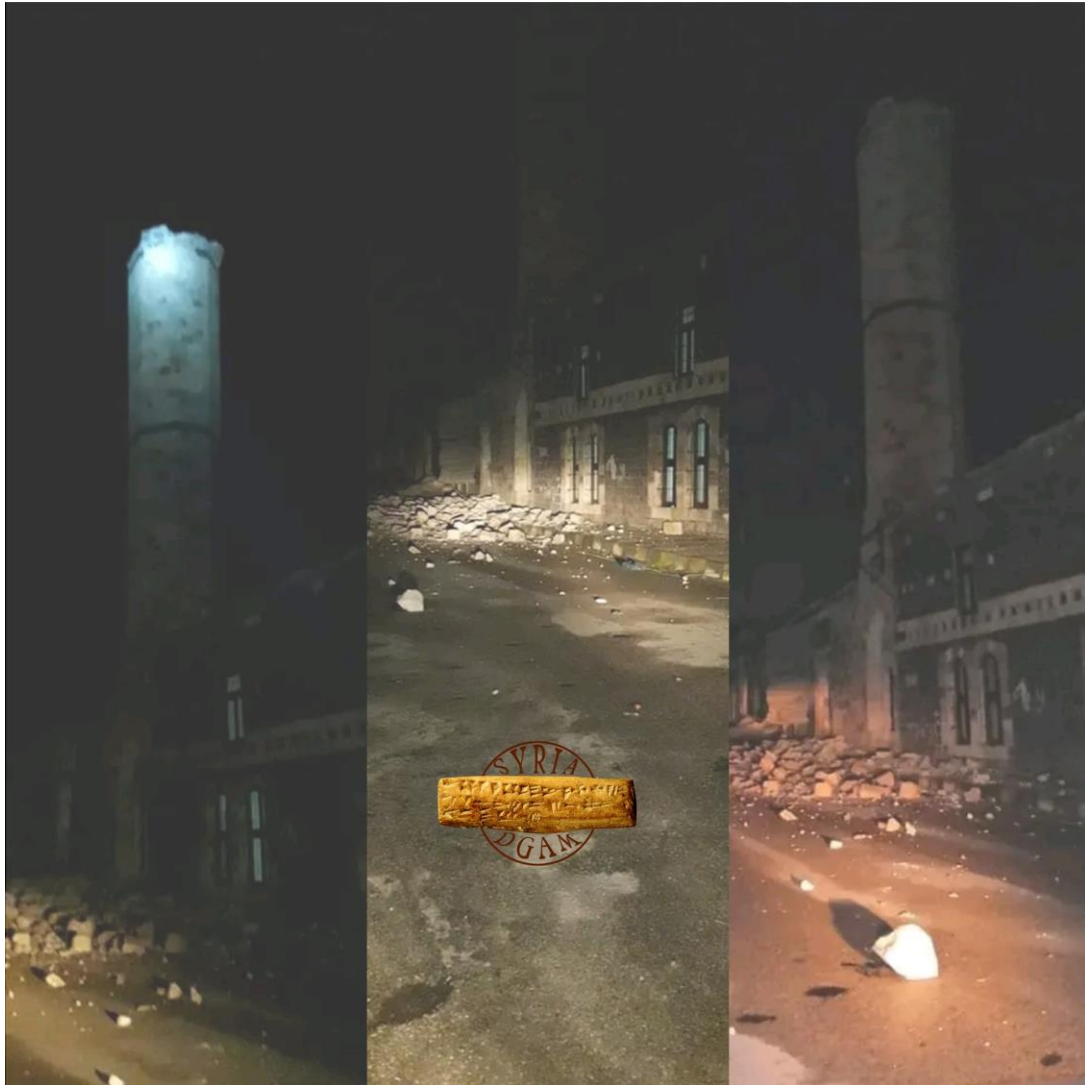
To date, we have not received accurate information from the city of Homs on any damages to the heritage sites, as well as the ancient city of Palmyra, and it is known so far that the minarets of the Great Mosque in Qusayr have completely fallen.

Homs, Heritage building damaged - February 6, 2023, following an earthquake (DGAM)

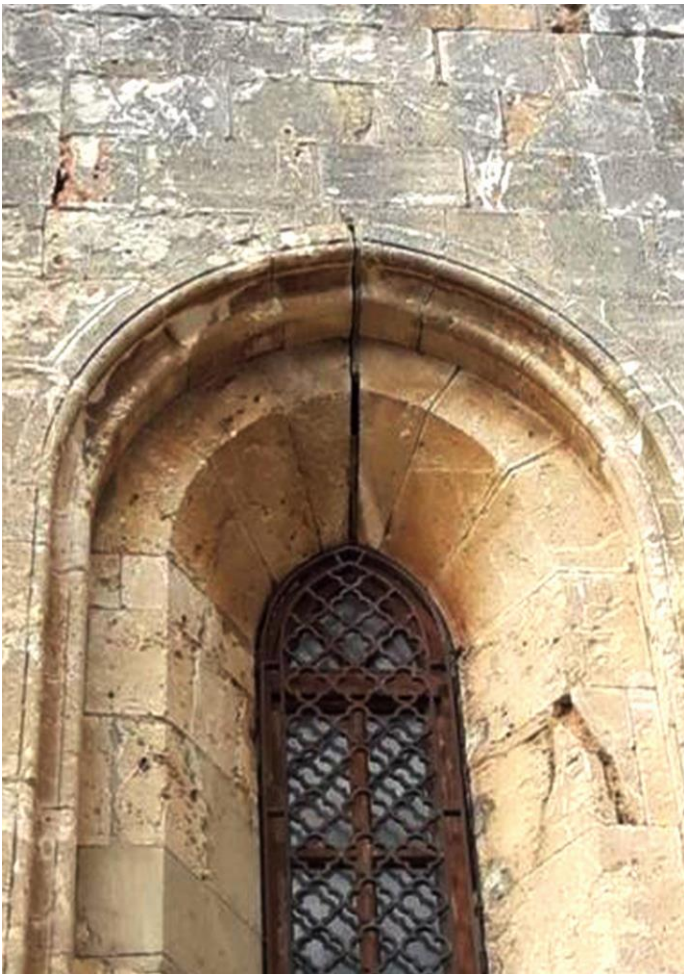
**Tartous Cathedral**, which is the building of the Tartous Museum, cracks occurred in the inner museum window to the right of the entrance, as well as serious cracks on the decorative columns of the windows from the inside, also there was a new crack appeared after the earthquake on the museum's southern façade.

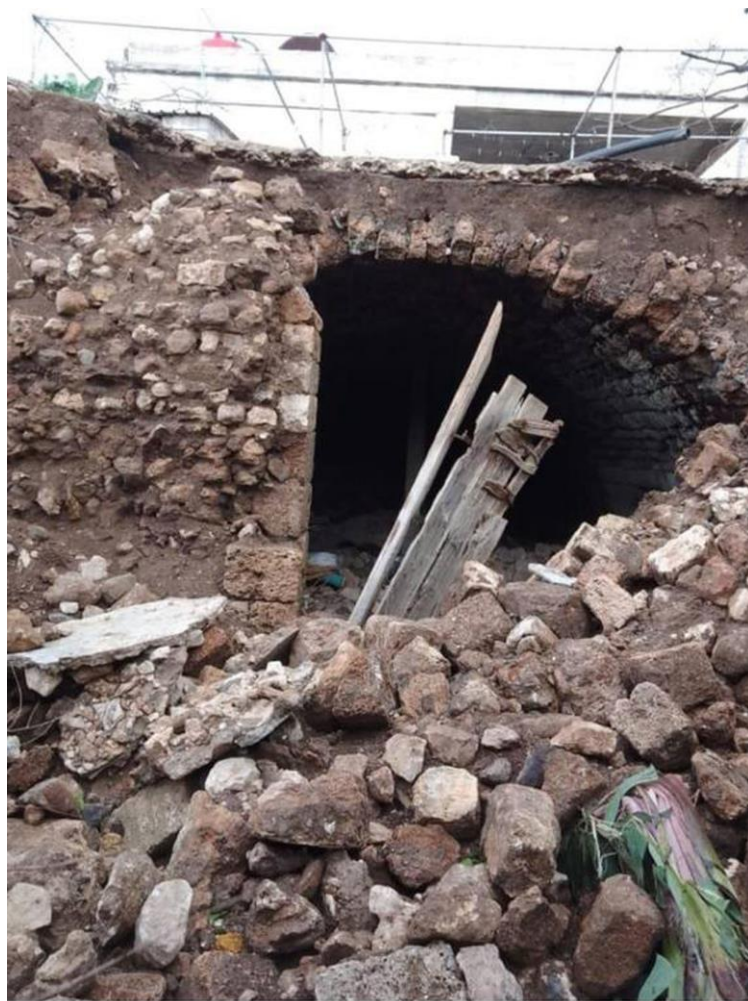
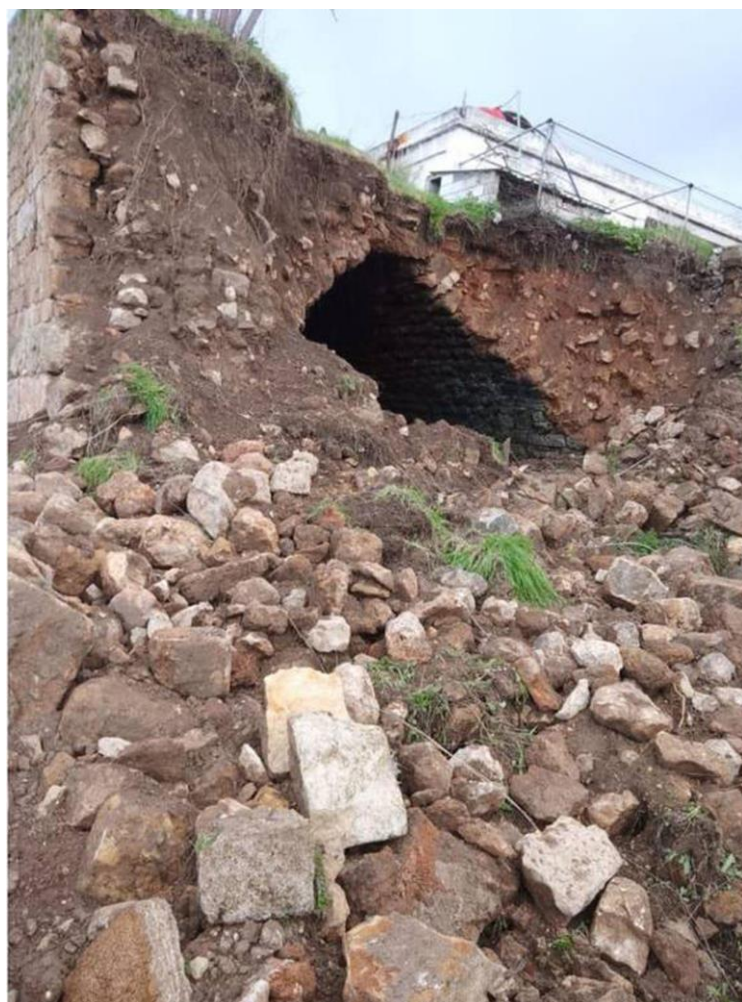
**Khanat Samryan-Tartos**, Collapse part of the remaining vaults.

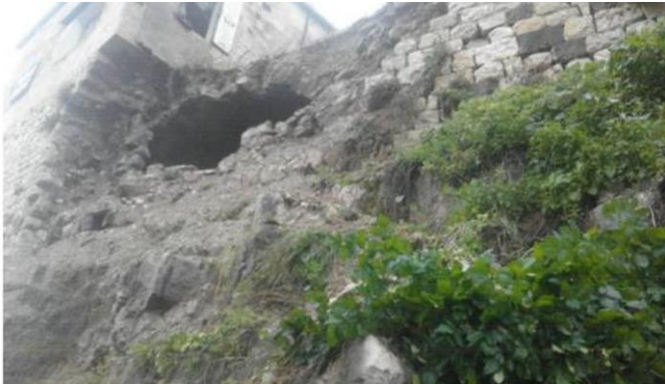
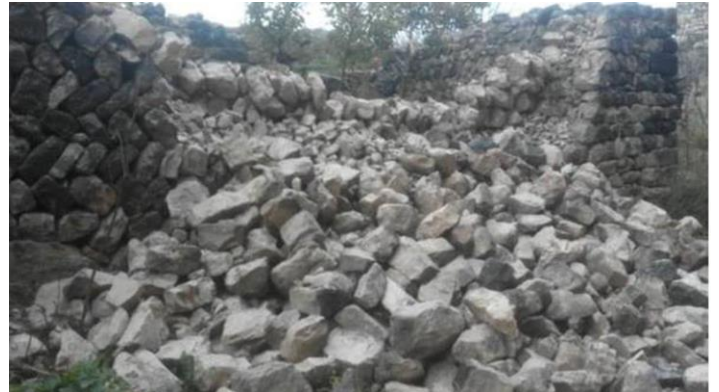
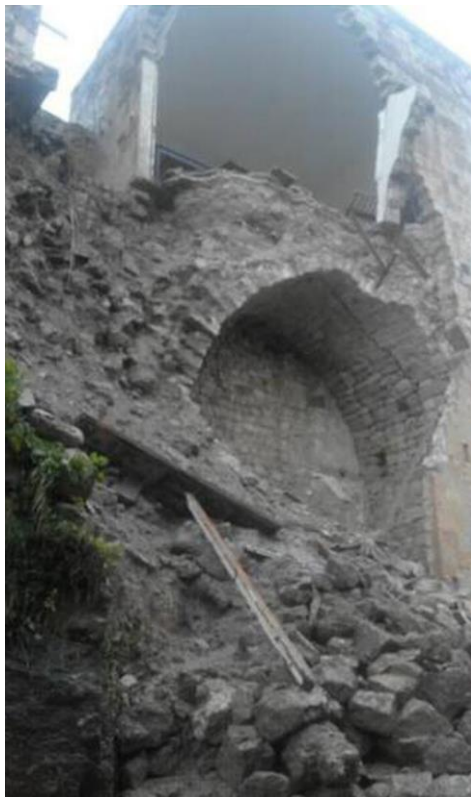
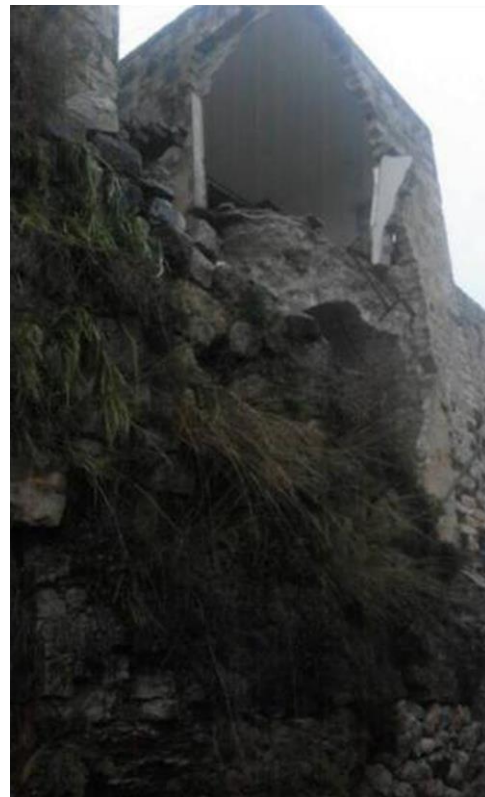
### Al-Khaoaby Citadel-Tartos:

- Collapse of some heritage buildings in the upper castle (Haret Al-Aghwar)
- Collapse of parts of the dome bearing the damaged buildings
- Cracks inside the Citadel Mosque and parts of the mud
- Collapse of parts of the remains of the walls of the residential village

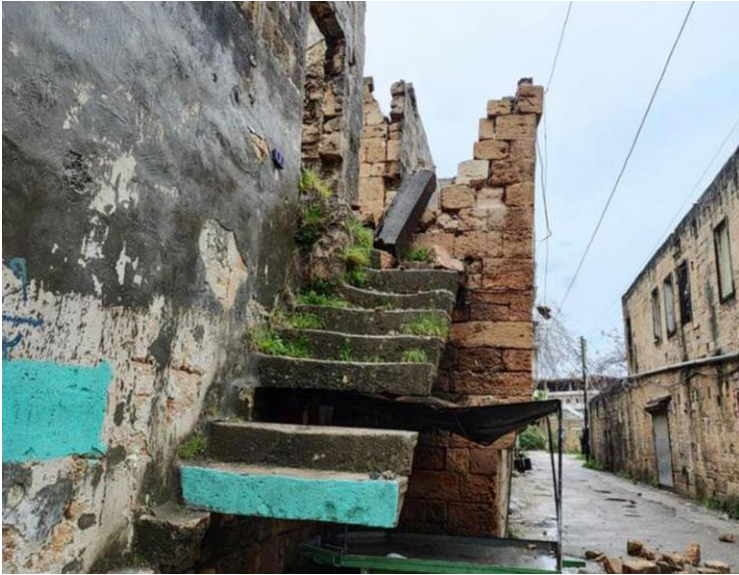
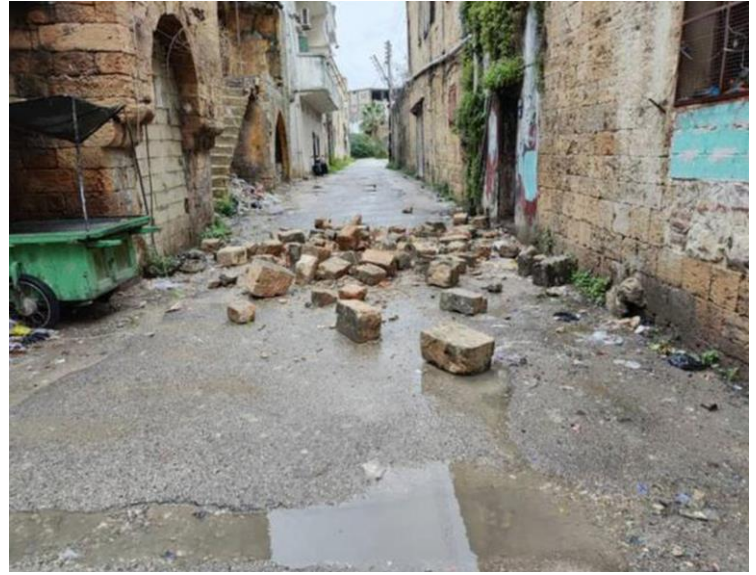
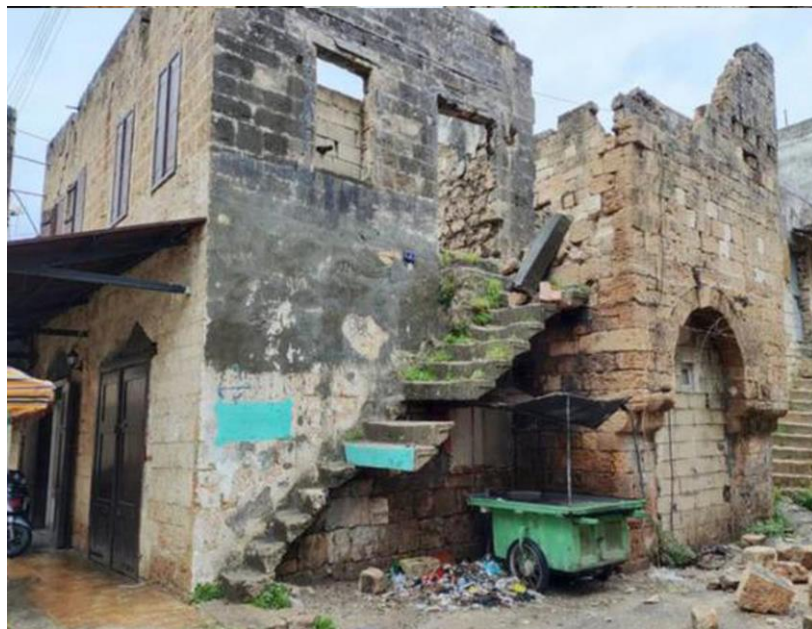
Many historic buildings suffered cracks in the walls and collapses in the ceilings.

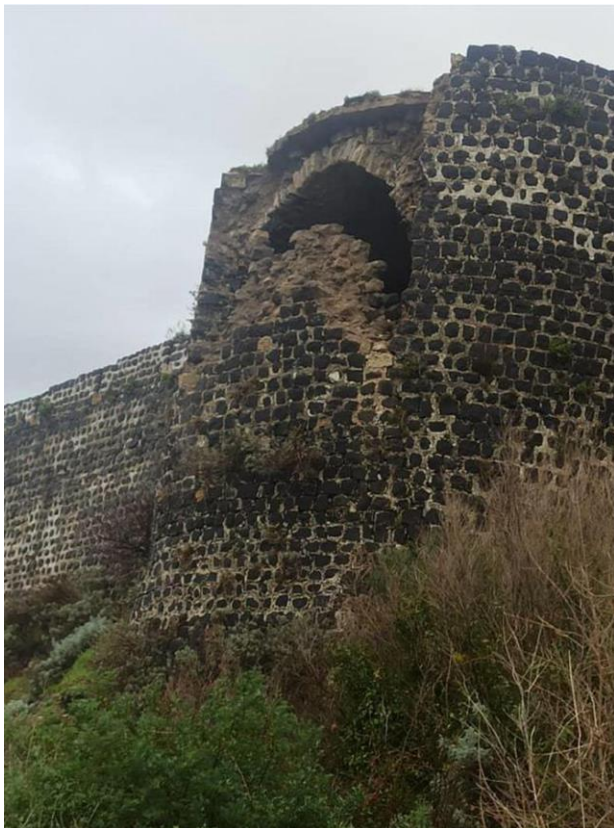
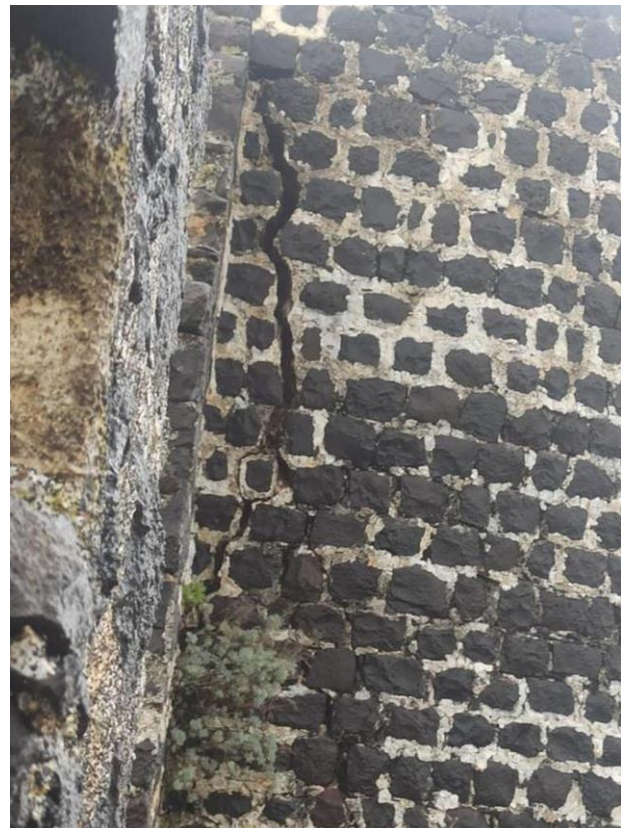
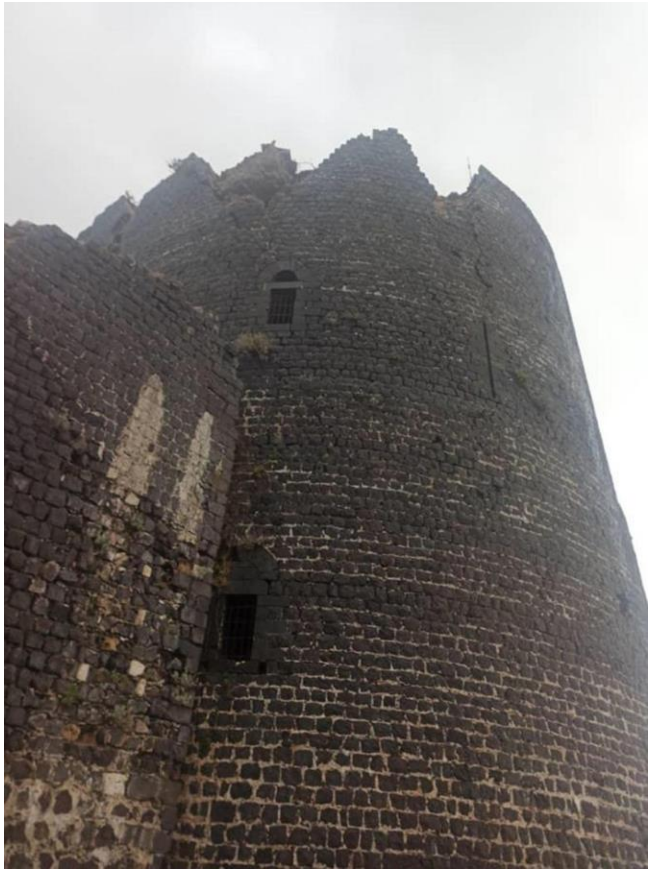
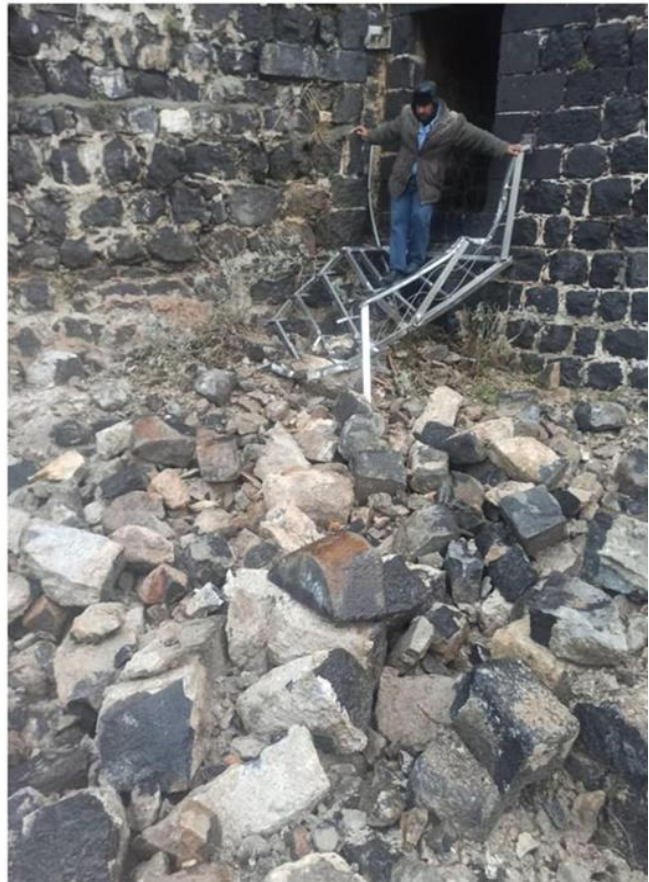
## Al-Marqab Citadel-Banyas:

- Collapse of parts of the western façade of the second tower located north of the main gate.
- A crack in the southwest corner of the main gate tower
- Collapse of part of the roof and wall of the eastern pavilion
- Partial collapse of some walls on the roof of Qalawun South Tower
- Cracks on both sides of the tower adjacent to the east gate at the second-floor level
- Collapse in residential villages and the inner wall.
- Complete collapse of the water drainage channel in the south of the church
- Collapse Parts of the walls of the buildings north of the Ottoman Khan
- Partial collapse of the northern furnace chimney in the furnace hall
- Collapse Part of the walls at the top of the Donjon tower with cracks and displacements on the western side

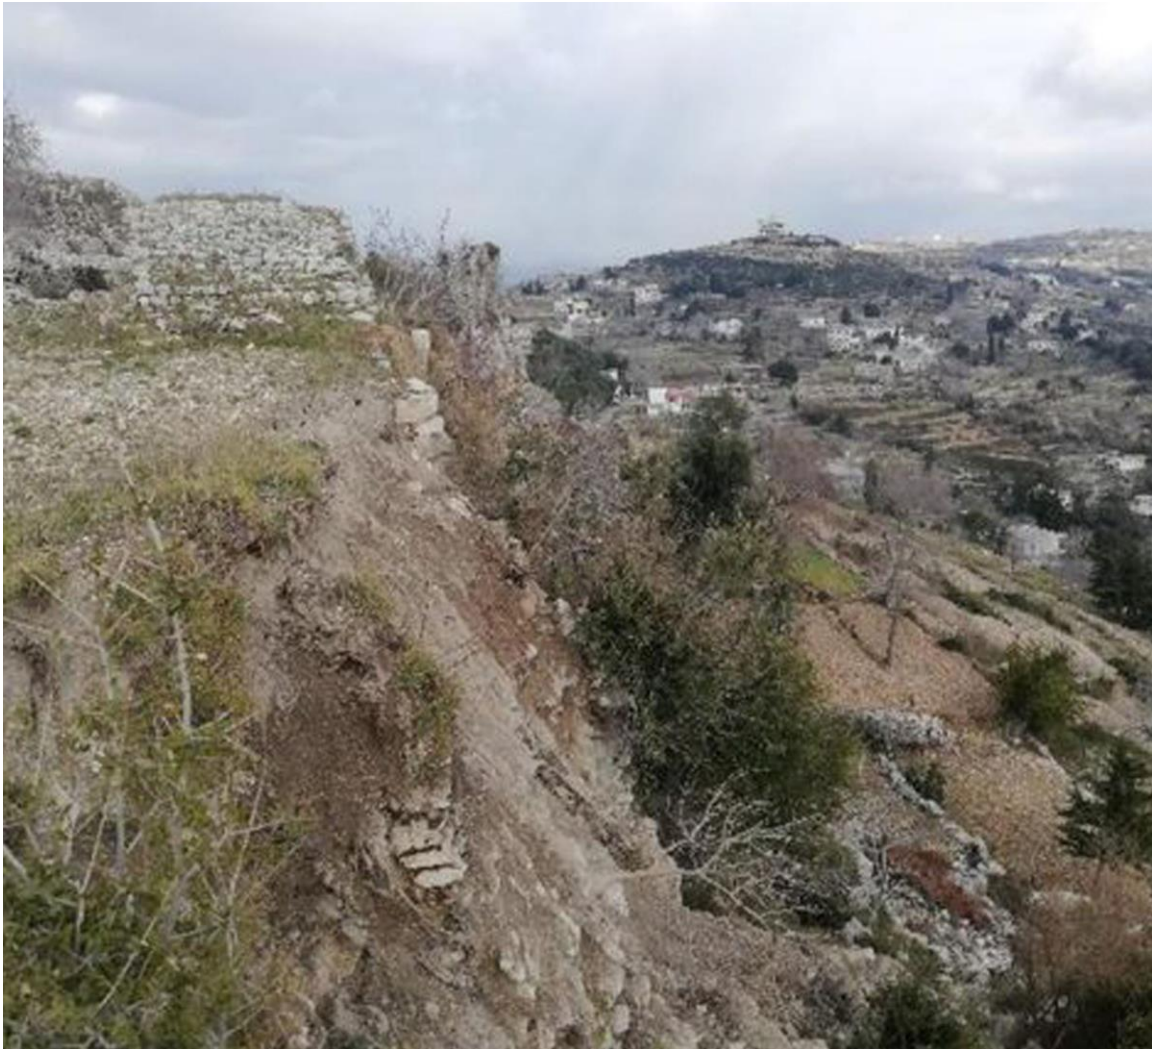
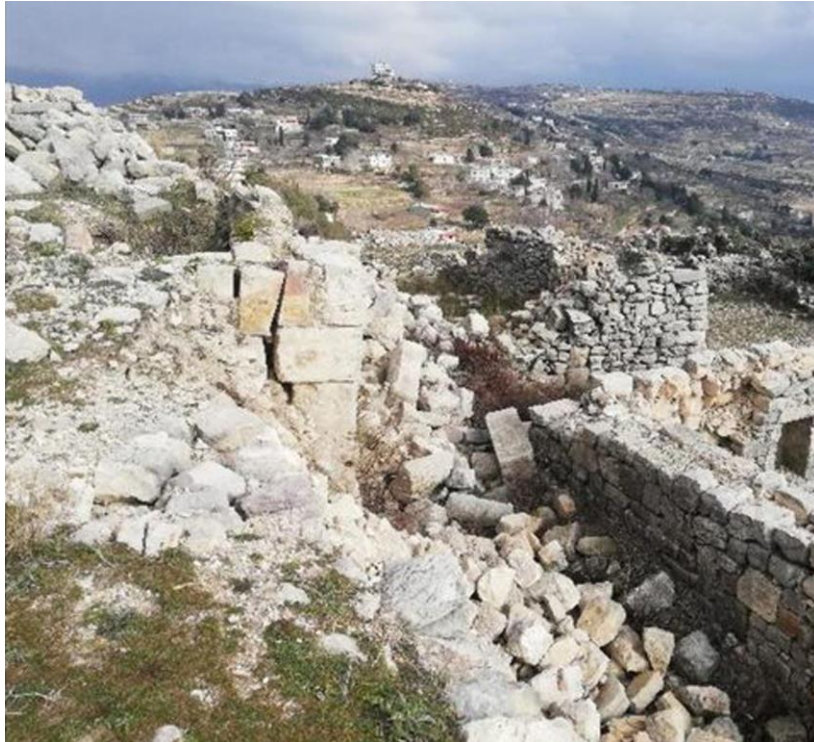
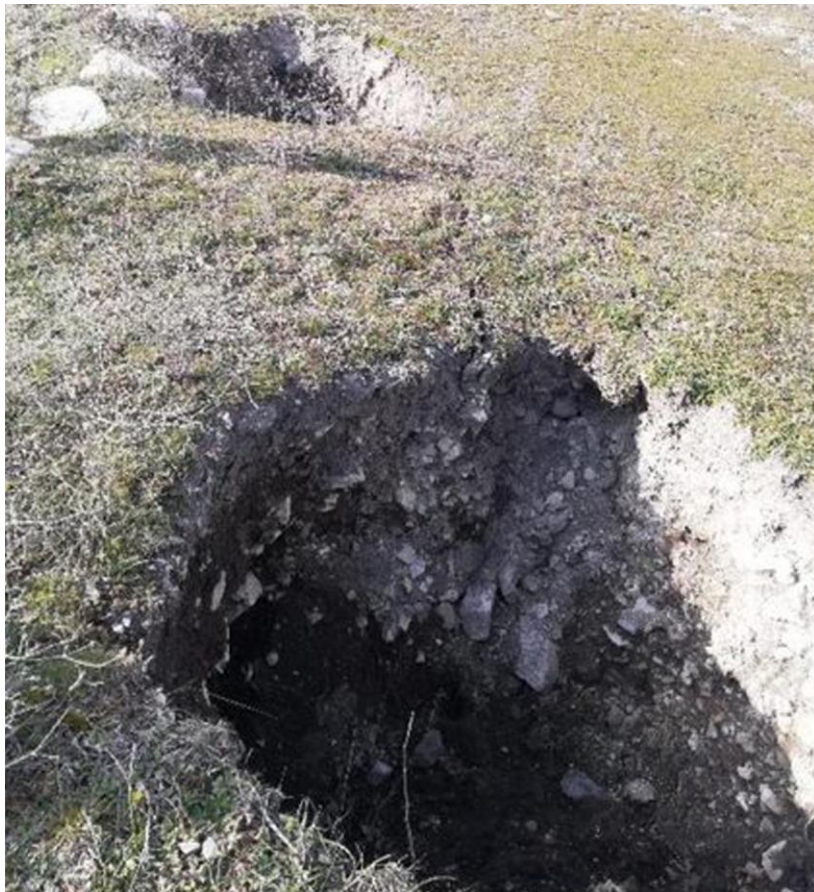
### Al-Oleqa Citadel- Baniyas:

- A crack in the rocky cliff bearing the castle.
- Partial collapses in the southern wall of the castle, with cracks adjacent to the wall
- Collapse parts of the cellars and the presence of cracks in others
- Collapse of part of the eastern vault adjacent to the entrance to the castle, in addition to the appearance of cracks
- Partial collapse of the north tower of the castle

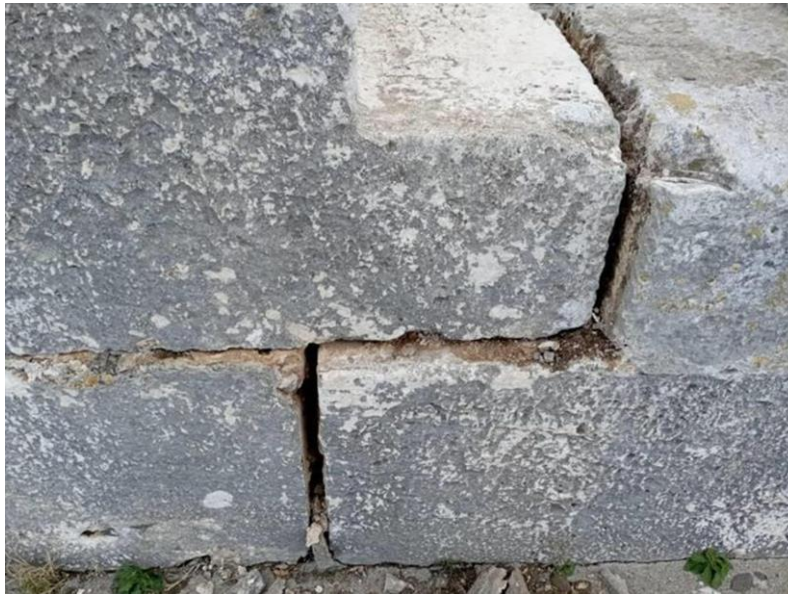
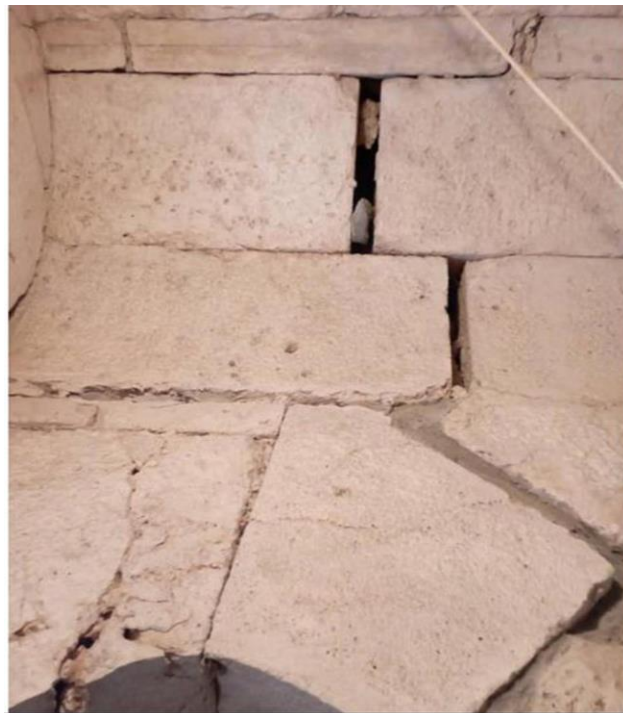
Safita old city- Safita Tower: A clear expansion of some old cracks, the emergence of new cracks, and the fall of some stones from inside and outside the tower, in addition to the appearance of a cavity in the floor of the first floor.

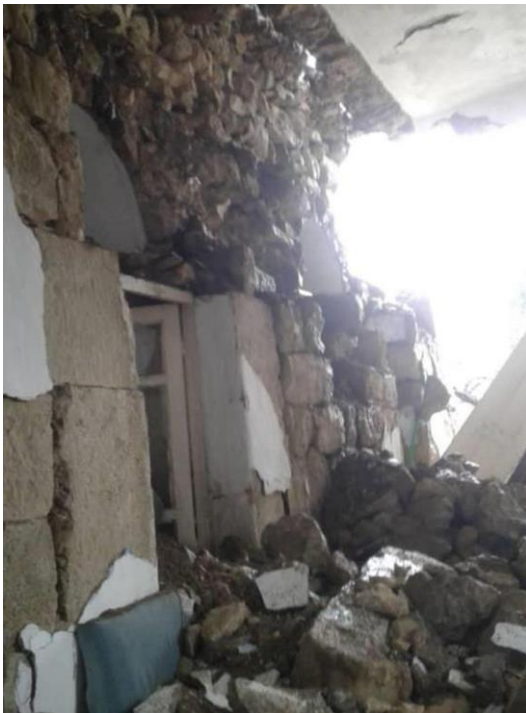
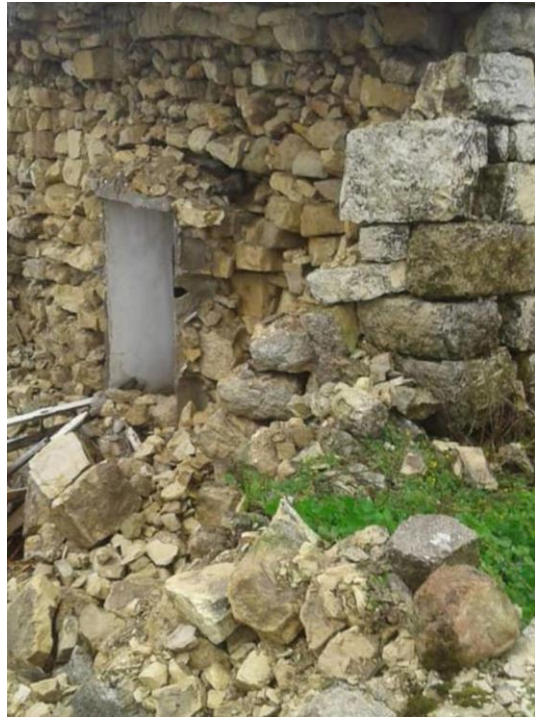
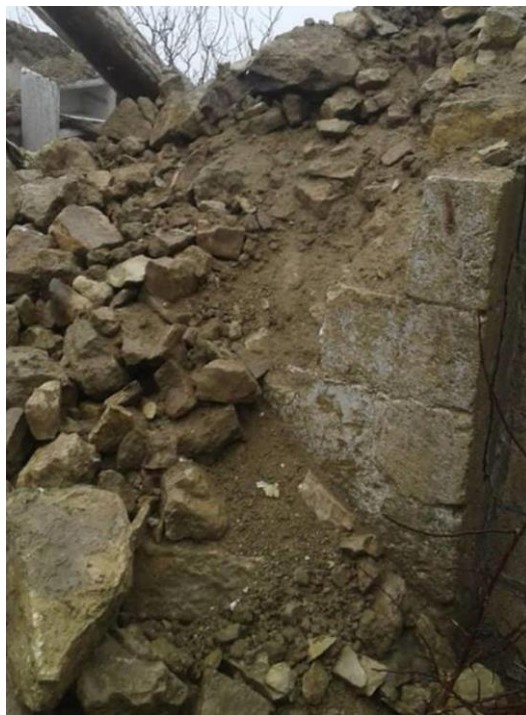
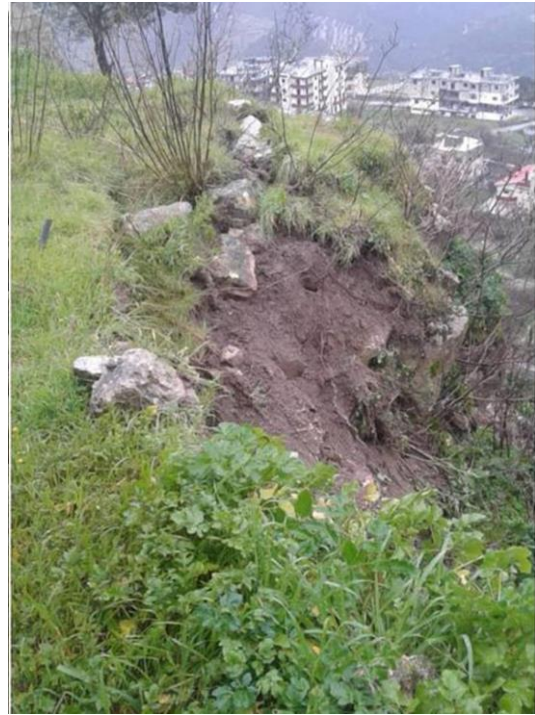
Citedal, Al-Qadmous.

- Collapse some parts from the residential heritage buildings inside the castle, and the rest are threatened with collapse.
- Fallen stones from the arch of the main entrance to the castle.
- Some stones fall off the rocky cliff that holds the castle.
- Maqam Sinan Rashad al-Dien, collapse one wall.
